KANEPACKAGE PHILIPPINE INC.

MINUTES OF THE MEETING

AGENDA: TO DISCUSS THE PROBLEM IN ITEM SIZE PRODUCTION (UNIT 1A EUROPE #10)

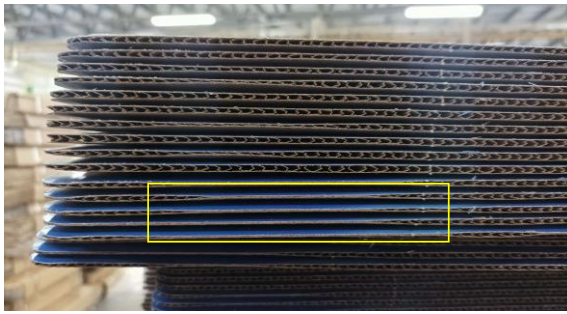
FLATTENED UPPER FLAP

NOTE 2: Panel feeding occurred because of the flattened upper flap of the other panels that send it up on the roller due to different heights of panels and machine roller they also contribute to faster of corrugation problem.

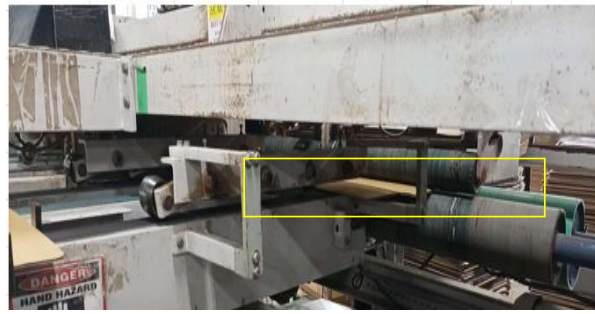
PANEL STUCK ON THE WEIGHTS ROLLER

NOTE 3: Because once the first good panel stuck on the weight roller, the next panel will move the first panel going to the weight roller will continue to roll & create a jam on the item feed feeder (iron).
