INVESTIGATION REPORT

SCRATCHES AND GLUE STAIN ENCOUNTERED IN ITEM CODE 516512800 (LIGHT FA EUROPE R;B)

Item Code :516512800

Item Description : LIGHT FA EUROPE R;B

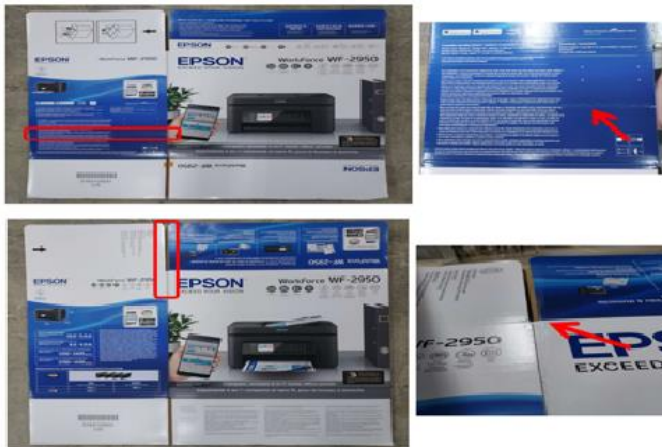
Reject Quantity : 26 PCS (GLUE STAIN 12 PCS)

Why 1: EXCESS GLUE ENCOUNTERED IN ITEM CODE 516512800 (LIGHT FA EUROPE R;B)
DURING MASS PRODUCTION IN SEMI AUTO GLUING 3

Why 2: EXCESS GLUE HAPPENED DUE TO WORN-OUT BEARING OF 1ST GLUING.

Why 3: BECAUSE THE BEARING AT FIRST GLUING IS ALREADY WIGGLED DURING APPLICATION OF GLUE.

RE-ORIENT THE OPERATOR REGARDING OF DAILY CHECKING OF PARTS OF THE MACHINE

THE ENGINEERING FIX THE 1ST GLUING BEARING
