INVESTIGATION REPORT

PEEL OFF ENCOUNTERED IN ITEM CODE 516298200 (LOUVRE 2 MCX ICB FOR ASIA; C

Customer : EPSON PRECISION (PHILIPPINES) INC, -IJP

Item Code : 516298200

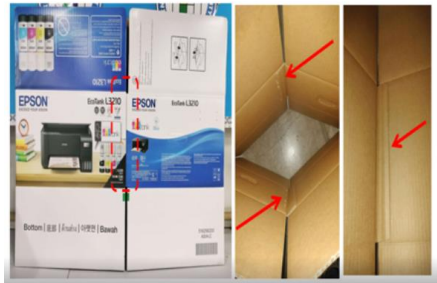
Why 1: PEEL OFF ENCOUNTERED IN ITEM CODE 516298200 (LOUVRE 2 MCX ICB FOR ASIA; C) DURING PROCESS

Why 2: PEEL OFF CAUSED BY EXCESS GLUE

Why 3: THERE WAS EXCESS GLUE BECAUSE THE 2ND GLUING WAS APPLIED FURTHER INSIDE THE PANEL AND AWAY FROM THE GLUE TAB.

Why 4: THICK GLUE GOT ON THE EDGE OF THE GLUE TAB SO THERE WAS AN EXCESS INSIDE THE PANEL WHEN THE OPERATOR MOVED THE GLUE PLATE, AFFECTING THE PLACE OF THE GLUE ROLLER APPLICATION BECAUSE THE ROLLER MOVED AWAY FROM THE GLUE TAB OF THE PANEL.

NOTE: THE OPERATOR ADJUST THE GLUE PLATE BECAUSE HE NOTICED THE UNEVEN GLUE ON THE ROLLER

Why 5: OPERATOR ALSO FAILED TO UNDERGO TRIAL AFTER THE ADJUSTMENT OF THE GLUE PLATE.

QA AND OPERATOR SORT THE AFFECTED ITEMS

RE-EDUCATE THE OPERATOR ABOUT THE FOLLOWING THE STANDARD PROCESS

IMPLEMENT TO THE OPERATOR THAT EVERY ADJUSTMENT THERE MUST HAVE TRIAL
