<b>KANEPACKAGE PHILIPPINE INC.</b> No. 5 Ring Road LISP II, Brgy. La Mesa, Calamba City, Laguna Telephone No. (049) 545-7166 to 69 Fax No. (049) 545-6302	<h1>INVESTIGATION REPORT</h1>		
	Prepared By:	Check By:	Approved By:
	K.DIAZ QA-IE/ Prodn IE	N. CEPEDA QA/ Prodn SV	R. MIRANDA KPLIMA Operations Gen. Mngr.
<b>DATE:</b>	JUNE 27, 2023

<b>1.1. ISSUE:</b>	
	PEEL OFF
<b>1.2. ITEM DESCRIPTION:</b>	
<b>PART CODE:</b>	516512900
<b>PART NAME:</b>	LIGHT 2 MB AMERICA
<b>1.3. BACKGROUND:</b>	
<b>PICTURE</b>

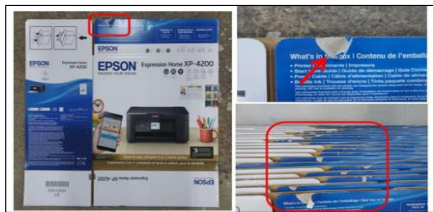
<b>DETAILS:</b> >Inhouse Detection : PEEL OFF >Lot size: 1168pcs > Reject Qty: 148pcs >Rejection Rate: 12.67%

<b>WHY 1:</b>	ITEM PEELED OFF ON THE UPPER FLAP CLASS B WHILE DETACHING IT AND THE MANUAL STRIP IT WAS USED ON.
<b>WHY 2:</b>	PEEL OFF OCCURED BECAUSE THE ITEM WAS UNCUT.
<b>WHY 3:</b>	UNCUT OF AN ITEM ENCOUNTERED DUE TO THE CONDITION OF THE BACKING TAPE (FLATTENED) ON THE PATTERN SHEET BECAUSE OF EXCESSIVE USE/PUNCH. REMARKS: WHEN ENCOUNTERED UNCUT, THE OPERATOR STOP THE PROCESS AND CHECK THE SETTINGS AND CHECK THE UNCUT PORTION AND IMMEDIATELY PUT A BACKING TAPE.
<b>WHY 4:</b>	DURING THE DIECUT PROCESS, THE CATCHER OPERATOR SKIPS THE MANUAL BROWSING OF AN ITEM, RESULTING IN A HIGH LOT OF REJECTION. NOTE: FOUND 148PCS REJECT OUT OF 1168PCS DURING SEMI AUTO PROCESS AND THEY REWORK FOR THE AFFECTED ITEMS.

ACTION ITEMS	Target Date:	Person In-charge
1. PUT BACKING TAPE ON THE UNCUT PORTION 2. THE SUBLEADER OF SEMI AUTO INFORMED THE SUBLEADER OF DIECUT THAT AN UNCUT WAS FOUND. THE SUBLEADER EDUCATES HIS OPERATOR ON MANUAL BROWSING AND INFORMS THE LEADER AND SENIOR OPERATOR ON ANY ABNORMALITIES ENCOUNTERED.	JUNE 27, 2023	PIC: OPERATOR AND SUBLEADER

1	RE-EDUCATE THE OPERATORS FOR TIGHTENING THE MANUAL BROWSING AND INFORM THEIR SUBLEADER OR SENIOR OPERATOR FOR ANY ABNORMALITIES BEING ENCOUNTERED.
2	THE TOOLING CUSTODIAN WILL TIGHTEN THE INSPECTION OF THE MATERIALS (BLADE, PLATE, PATTERN SHEET) PRIOR TO PRODUCTION.
