INVESTIGATION REPORT

GLUE STAIN ENCOUNTERED IN ITEM CODE 516512800 (LIGHT FB AMERICA)

Item Code : 516512800

Item Description : LIGHT FB AMERICA

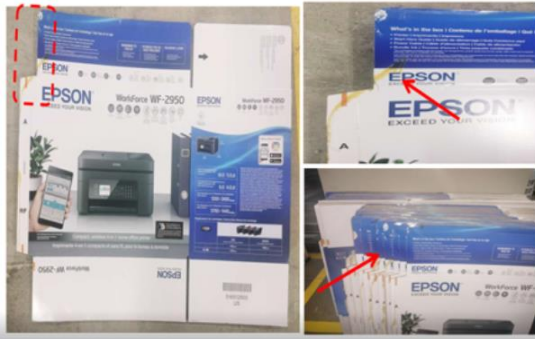
III. ILLUSTRATION OF THE PROBLEM

Why 1: GLUE STAIN ENCOUNTERED IN ITEM CODE 516512800 (LIGHT FB AMERICA) DURING PROCESS AT GLUING MACHINE 3

Why 2: ITEM WAS WARP THAT CAUSES OF DOUBLE FEEDING & DIAGONAL POSITION UPON PASSING THE CONVEYOR.

Why 3. DURING PROCESS OF ITEM THE ROLLER BEAM NOT ABLE TO REACH THE PANELS THAT LEAD TO GLUE STAIN.

SUBLEADER IS POSITIONED IN THE PRESSING AREA TO ADJUST THE ALIGNMENT OF THE INCOMING PANEL

PLACING A RUBBER ROLLER BESIDE THE PRESSING AREA (TO FLATTEN THE WARP ITEM)
