1.1. ISSUE:	
	INVERTED PAD BLOCKS ATTACHMENT
1.2. ITEM DESCRIPTION:	
PART CODE:	516445502
PART NAME:	PAD ASSY,LB
1.3. BACKGROUND:	
PICTURE

INVESTIGATION REPORT

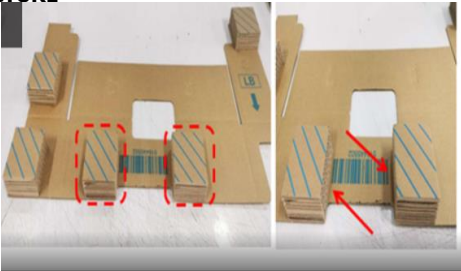
DETAILS: <i>LOT QTY: 962</i> <i>REJECT QTY: 2 EA</i> <i>REJECTION RATE: 0.21%</i> <i>JO#: 39907</i> <i>DETECTED BY PRODUCTION LUCIDA</i>

WHY 1:	Encountered wrong assembly (wrong pad block attachment) on item 5164455-02 PAD ASSY, LB.
WHY 2:	Assigned operator was not skilled. Note: The operator was still under training assessment and qualification.
WHY 3:	Prior endorsement in the line assembly, no evaluation for qualification has been done.
WHY 4:	Implementation of standard training plan for newly endorsed manpower allocated for LUCIDA assembly line was not followed and monitored by the in-charge sub-leader.
WHY 4:	The sequence or flow of training plan was too general or not specific per day assessment. Note: Existing was on weekly assessment performance and evaluation.

WHY 1:	Encountered flow out of wrong assy (wrong pad block attachment) on item 5164455-02 PAD ASSY, LB in the Lucida assembly line.
WHY 2:	Operator was confused on the poka yoke markings prior attachment of pad blocks.
WHY 3:	Lack of training assessment for newly endorsed manpower in Lucida Assembly line.
WHY 4:	Operator was immediately assigned to line (running mass production) without proper evaluation. Note: No verification of the actual output of new operator prior endorsement to QA inspector.
WHY 5:	Output of the newly operator was mixed with the output of the skilled operator. Note: There is no separate location for the output produced by new operator and skilled operator.

ACTION ITEMS	Target Date:	Person In-charge
SORTING/HOLD THE RAW MATS FOR VERIFICATION	230712	OPERATOR/QA
REMIND THE OPERATOR FOR THE ISSUE OF INVERTED PAD BLOCKS ATTACHMENT	230712	OPERATOR

1	Reorientation of Lucida operator regarding the encountered major defects. Agenda: OPL- Work guidance regarding the proper orientation and attachment of pad blocks to pad base.	PIC: Production IE/ Subleader Target Date: 230711
2	Revision of training plan for newly endorsed manpower in LUCIDA assembly line for more specific flow of training assessment.	PIC: Production IE/ Subleader Target Date: 230712
3	Inclusion of separate table of newly endorsed manpower in Lucida assembly line for tighten inspection by assigned sub-leader/line leader.	PIC: Production IE/ Subleader Target Date: 230713
