KANEPACKAGE PHILIPPINE INC. No. 5 Ring Road LTSP II, Brgy. La Mesa, Calamba City, Laguna Telephone No. (049) 545-7166 to 69 Fax No. (049) 545-6302	INVESTIGATION REPORT		
	Prepared By:	Check By:	Approved By:
	K.N.ACUIN	N. CEPEDA	R. MIRANDA
DATE:	230727	QA-IE/ Prodn IE	QA/ Prodn SV
		KPLIMA Operations Gen. Mngr.

I. PROBLEM DESCRIPTION

1.1. ISSUE:	
	SCRATCHES
1.2. ITEM DESCRIPTION:	
PART CODE:	516298200
PART NAME:	LOUVRE 2 MCX ICB FOR ASIA
1.3. BACKGROUND:

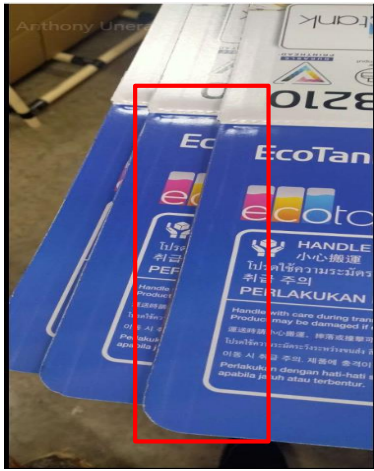
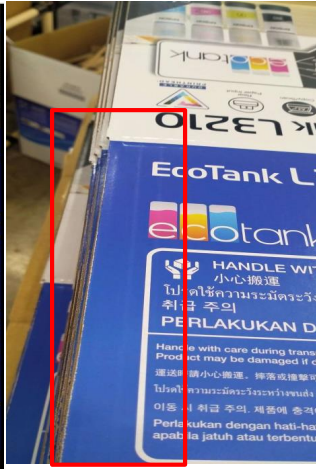
SLIGHT SCRATCHES FROM DIE CUT PROCESS

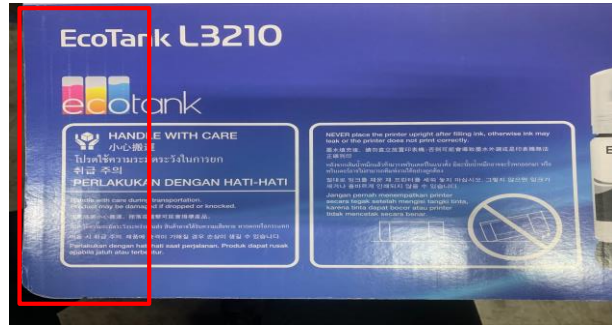
SCRATCHES ACCUMULATED IN SEMI AUTO GLUING MACHINE 4

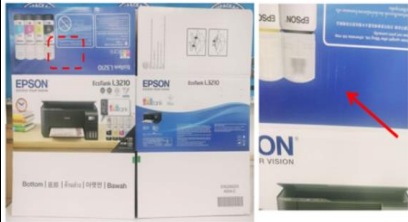
DETAILS: > LOT QTY: 730EA > <i>REJECT QTY: 42EA (5.75%)</i> > JO#: 40527 > <i>MAJOR REJECT/DETECTED BY QA</i>

WHY 1:	Scratches encountered on item 516298200 Louvre 2 MCX FOR ASIA during gluing process at machine 4.
WHY 2:	During gluing process, scratches been observed by the QA inspector and immediately stop the running to check occurrence of scratches. Note: Encountered 42 pcs/ 730 pcs but noticed on the last pallet running.
WHY 3:	Upon checking of panels prior gluing, subleader and QA observed that there was already scratches. Note: a. Scratches was getting worse when it was processed on gluing. (Please see attached picture.) b. Upon verification of the materials used, we seek help to ME and QA for the rub test. Rub Test Result: PASSED (Please see attached picture.)
WHY 4:	Upon checking on the diecut process (Diecut 2), scratches encountered due to scrapes of the panel on the guide bar of the diecut feeder.
WHY 5:	Scrapes of panels on the guide bar still have tape adhesive causing scratches on the item.

ACTION ITEMS	Target Date:	Person In-charge
Upon encountering scratches, subleader in-charge tries to switch position of affected panel (PANEL B) to the position of the other panel (PANEL A) to verify if the occurrence of scratches was still on Panel B. Note: Scratches still encountered on Panel B.	230719	Operator
Sort of raw materials prior gluing process.	230719	Operator and QA

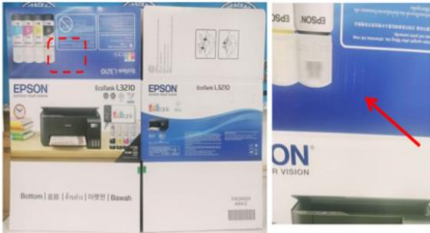
DETAILS: > LOT QTY: 730EA > <i>REJECT QTY: 42EA (5.75%)</i> > JO#: 40527 > <i>MAJOR REJECT/DETECTED BY QA</i>

WHY 1:	SCRATCHES ENCOUNTERED IN ITEM CODE 516298200 LOUVRE 2 MCX FOR ASIA (AFFECTED PANEL B) DURING PROCESS AT GLUING MACHINE 4
WHY 2:	QA INSPECTOR OBSERVED SCRATCHES DURING THE GLUING PROCESS AND IMMEDIATELY HOLD THE RUNNING FOR THE OCCURRENCE OF SCRATCHES. NOTE: ENCOUNTERED 42 PCS OUT OF 732 PCS BUT BEEN NOTICED ON THE LAST PALLET RUNNING
WHY 3	UPON CHECKING OF RAW MATERIALS (PANELS FOR GLUING) SUBLEADER AND QA OBSERVED THAT THERE WAS ALREADY SCRATCHES ON THE ITEM NOTE: SCRATCHES WAS GETTING WORSE WHEN IT WAS PROCESS ON GLUING. NOTE: UPON VERIFICATION OF THE MATERIALS USED. WE SEEK HELP TO THE M.E AND QA FOR THE RUB TEST OF THE RAW MATERIALS (BASED ON THE RESULT THE PRINTED SHEET PASSED THE TEST)
WHY 4:	UPON CHECKING ON THE DIE CUT PROCESS (ETERNA DIE-CUT 2) SCRATCHES ENCOUNTERED DUE TO SCRAPES OF THE PANELS ON THE GUIDE BAR OF DIECUT FEEDER
WHY 5:	SCRAPES OF PANELS ON THE GUIDE BAR STILL HAVE TAPE ADHESIVE

ACTION ITEMS	Target Date:	Person In-charge
UPON ENCOUNTERING SCRATCHES, SUBLEADER INCHARGE TRIES TO SWITCH POSITION OF AFFECTED PANEL (PANEL B) TO THE POSITION OF OTHER PANEL (PANEL A) TO VERIFY IF THE OCCURRENCE OF SCRATCHES WAS STILL ON PANEL B. (SCRATCHES STILL ENCOUNTERED ON THE PANEL B)	230719	OPERATOR
SORT OF RAW MATERIALS BY SEMI AUTO GLUING OPERATOR WITH THE HELP OF QA	230719	OPERATOR & QA

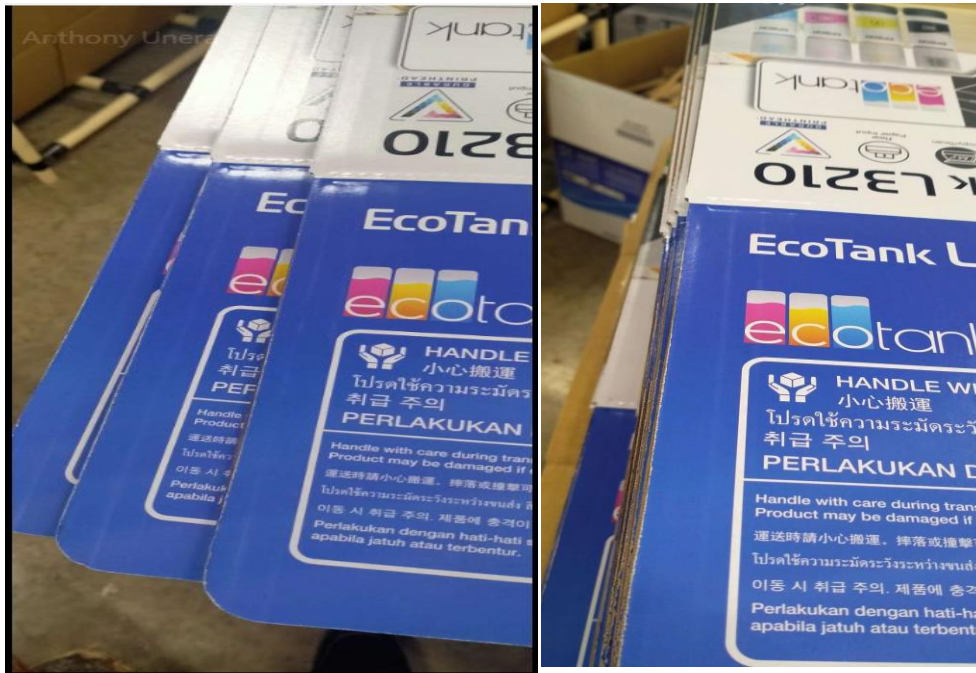
SLIGHT
SCRATCHES
FROM DIE CUT
PROCESS
