# **INVESTIGATION REPORT**

1.1. ISSUE:		
	DAMAGED	
1.2. ITEM DESCRIPTION:		
PART CODE:	515907800	
PART NAME:	LOUVRE 2 MAX	
1.3. BACKGROUND:		
DETAILS:

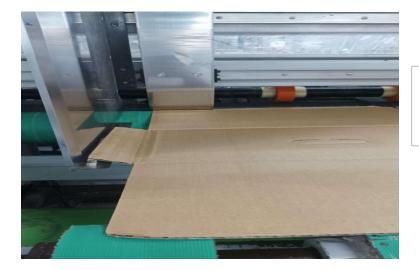
WHY 1:	DAMAGED ENCOUNTERED ON ITEM CODE 515907800 LOUVRE 2 MAX (AFFECTED: PANEL A) DURING PROCESS AT SEMI AUTO GLUING MACHINE 4
WHY 2:	DURING RUNNING, THE ITEM SCRAPES ON THE FEEDER STOPPER OF THE MACHINE
WHY 3	FEEDER STOPPER WAS OBSERVED TO ENCOUNTERED IMPROPER MOVEMENT DURING RUNNING NOTE: FOLDER IN-CHARGE FAILED TO DETECT DAMAGED PANEL DURING FOLDING PROCESS.
WHY 4: IMPROPER MOVEMENT OF THE FEEDER STOPPER WAS DUE TO ENCOUNTERED LOOSEN LOCK SCREW NOTE: CHECKPOINTS OF THE FOLDER IN-CHARGE WAS NOT SPECIFICALLY STATED ON THE WORK INSTRUCTION.	
WHY 5:	LOOSENING OF THE LOCK SCREW WAS DUE TO IMPROPER TIGHTEN SET UP OF THE LOCK

**DEMONSTRATION PICTURE OF STOPPER SCRAPED THE PANEL A**

1	ORIENTATION OF PROPER SET UP OF LOCK SCREW FOR FEEDER STOPPER	230731
2	ORIENTATION FOR THE CHECK POINTS OF GLUING OPERATOR IN-CHARGE. FEEDER CHECK POINTS,FOLDER CHECKPOINTS, and CATCHER CHECKPOINTS	
3	GENERATE OF OPL (ONE POINT LESSON) FOR THE PROPER SET UP OF LOCK SCREW FOR FEEDER STOPPER.	
4	REVISION OF WI-LPR-002-01(GUIDELINES OF SEMI AUTO GLUING MACHINE) TO INCLUDE DETECTION OF DAMAGE INSIDE THE BOX AS ONE THE CRITICAL CHECKPOINT OF THE FOLDER OPERATOR

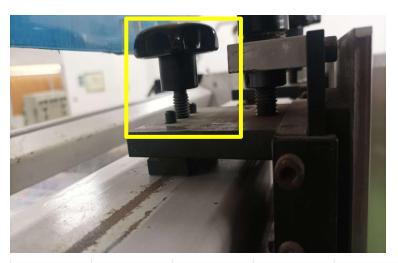
**LOOSE LOCK SCREW OF FEEDER STOPPER**

4.5 Adjust the sheet stopper based on the thickness of the boards. Unang set-up, the feeder operator must check the lock screw and star knob to see if the thread of the screw is in good condition.
