KANEPACKAGE PHILIPPINE INC. No. 5 Ring Road LISP II, Brgy. La Mesa, Calamba City, Laguna Telephone No. (049) 545-7166 to 69 Fax No. (049) 545-6302	<h1>INVESTIGATION REPORT</h1>		
	Prepared By:	Check By:	Approved By:
	K.DIAZ QA-IE/ Prodn IE	N. CEPEDA QA/ Prodn SV	R. MIRANDA KPLIMA Operations Gen. Mngr.
DATE:	AUGUST 07, 2023

1.1. ISSUE:	
	BURSTING
1.2. ITEM DESCRIPTION:	
PART CODE:	516298200 / 516594700
PART NAME:	LOUVRE 2 MCXX / VINEGAR MDY
1.3. BACKGROUND:	
PICTURE

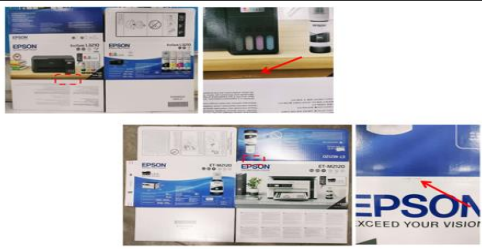
DETAILS: >Inhouse Detection :BURSTING >Lot size: 1633pcs > Reject Qty: 75pcs >Rejection Rate: 4.59%

WHY 1:	BURSTING OCCURRED ON THE FLAP (FOLDING PORTION) OF THE ITEM 516298200 AND 516594700 LOUVRE 2 MCX/ VINEGAR MDY
WHY 2:	BURSTING WAS DUE TO ENCOUNTERED SCRAP LEFT ON THE DIECUT PLATE.
WHY 3	WHILE RUNNING, A PIECE OF SCRAP GOT STUCK ON THE GRIPPER AND DROPPED ON THE DIECUT PLATE.
WHY 4:	THE PANEL WENT TO THE DELIVERY AREA WHEN THE MACHINE MALFUNCTIONED. THE OPERATOR GRABBED THE PANEL, UNAWARE THAT THE PIECE OF SCRAP WAS LEFT ON THE GRIPPER.

ACTION ITEMS	Target Date:	Person In-charge
REMOVING SCRAP ON THE GRIPPER BAR	03/08/2023	OPERATOR AND SUBLEADER

1	RE-EDUCATE THE OPERATOR WHEN THE MACHINE ENCOUNTERED MALFUNCTION AND CHECK THE SECTION AREA. (CUTTING AREA, STRIPPER AREA, DELIVERY AREA, GRIPPER). RUN THE MACHINE FOR AROUND 30 SECONDS AND INSPECT THE MACHINE IF THERE IS ANY REMAINED SCRAPS.
---	--
