**KANEPACKAGE PHILIPPINE INC.**

INVESTIGATION REPORT**DATE:** SEPTEMBER 14, 2023

1.1. ISSUE:	
	TEAR OFF
1.2. ITEM DESCRIPTION:	
PART CODE:	516587700
PART NAME:	LIONEL 2 MBL
1.3. BACKGROUND:	
PICTURE	DETAILS:

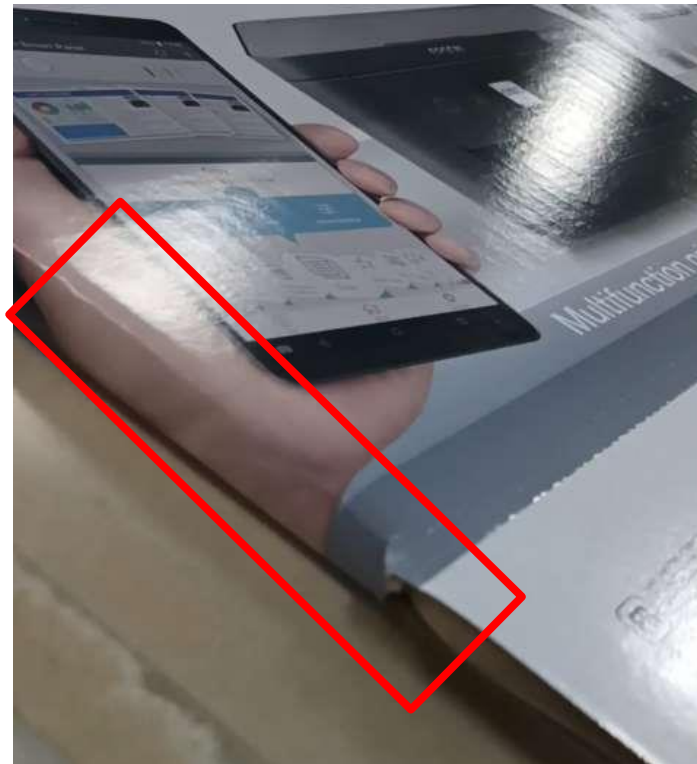
THE OUTSIDE APPEARANCE OF FOLDING SIDE IS THICK
