| KANEPACKAGE PHILIPPINE INC. No. 5 Ring Road LISP II, Brgy. La Mesa, Calamba City, Laguna Telephone No. (049) 545-7166 to 69 Fax No. (049) 545-6302 | INVESTIGATION REPORT | | |

I. PROBLEM DESCRIPTION

| PART CODE: | 516592600 |
| PART NAME: | LOUVRE 2 MJX |

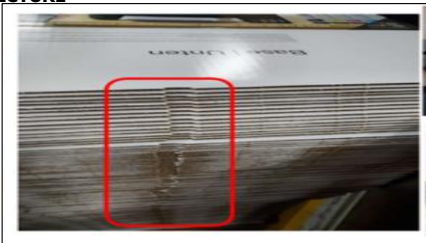
| PICTURE | DETAILS: >Inhouse Detection :DAMAGED >Lot size: 1085pcs > Reject Qty: 260pcs >Rejection Rate: 23.96% >JO#: 43114 |

| WHY 1: | DAMAGED OCCURRED ON THE LOWER PART OF THE ITEM. |

| ACTION ITEMS | Target Date: | Person In-charge |
|--|---|---|
| USE A NEW BLADE AND APPLIED 4M APPLICATION FOR THE BLADE | AUGUST 25, 2023 | SUBLEADER AND TOOLING CUSTODIAN |

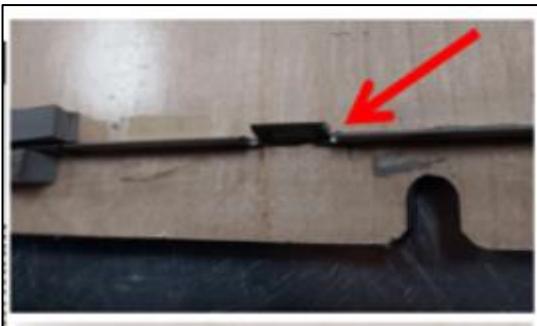
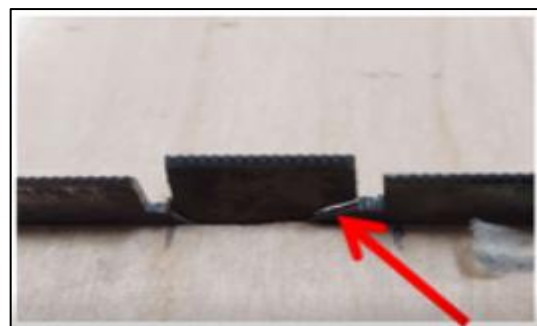
BROKEN BLADE

| WHY 2: | THE CUTTING BLADE SNAP ON THE DIEBLADE DURING MASS PRODUCTION. |
| WHY 3 | UPON CHECKING THE BLADE,THE DIEBLADE SHOTS HAS 280K+ AND THE NICKMARK IS ON THE BLADE'S BRIDGE MIGHT CAUSE TO BROKEN BLADE. |
| WHY 4: | THE OPERATOR DID NOT NOTICE THAT THE DIEBLADE WAS BROKEN AND BYPASS THE MANUAL BROWSING/CHECKING OF AN ITEM CAUSING HIGH MASS REJECTION. |

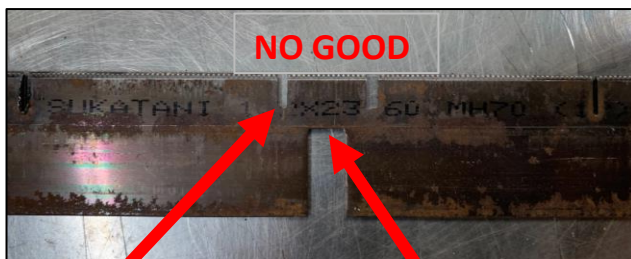
THE NICKMARK IS NEAR THE BRIDGE.

| 2 | THEY WILL JUST PLACE A NICKMARK AWAY FROM THE BRIDGE IF THE BLADE IS NEW AND DOESN'T HAVE ONE AND ALSO IN THE EXISTING BLADE. |
