**KANEPACKAGE PHILIPPINE INC.**

INVESTIGATION REPORT

DATE: SEPTEMBER 14, 2023

1.1. ISSUE:	
	TEAR OFF
1.2. ITEM DESCRIPTION:	
PART CODE:	516587700
PART NAME:	LIONEL 2 MBL
1.3. BACKGROUND:	
PICTURE

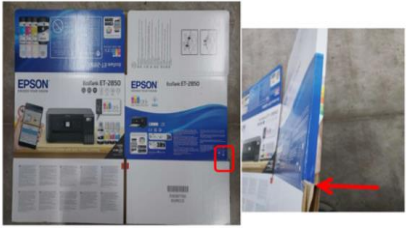
DETAILS: >Inhouse Detection :TEAR OFF >Lot size: 993pcs/ 1,689pcs > Reject Qty: 83pcs/ 191pcs >Rejection Rate: 8.36%/ 11.31%

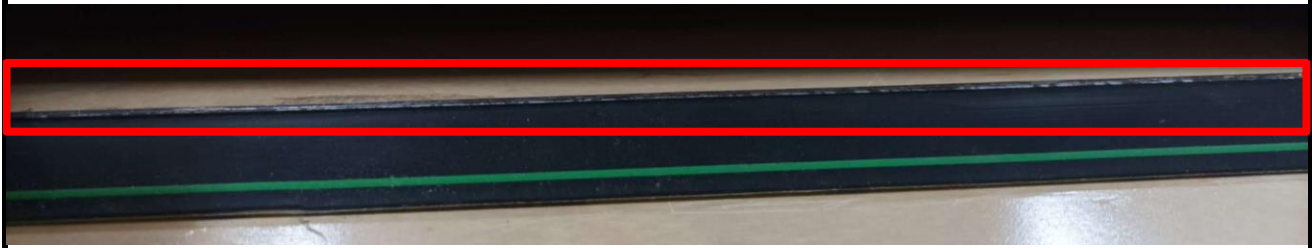
WHY 1:	TEAR OFF ENCOUNTERED ON ITEM 516587700 LIONEL 2 MBL AT SEMI AUTO GLUING PROCESS.
WHY 2:	TEAR OFF OCCURRED WHEN THE PANEL WAS BEING FOLDED BY THE OPERATOR NOTE: THE OPERATOR DIDN'T COMPRESS THE SIDES OF THE PANEL
WHY 3:	THE FOLDING LINE DOESN'T COMPRESS PROPERLY SO IT DEVELOPS A BUMP (BULDGE) ON THE SIDE OF THE FOLDING LINE
WHY 4:	THE CUSHION CREASE IS UNEVEN ON THE HEIGHT ON THE CREASING BLADE
WHY 5:	PROLONGED USE OF THE CUSHION CREASE HAS ALREADY COMPRESSED

UNEVEN HEIGHT OF CUSHION CREASE AND CEASING BLADE
NOTE: THIS BLADE IS A COMMON BLADE

CUSHION CREASE INCREASED BY 1MM TO MAKE IT EVEN TO THE CREASING BLADE

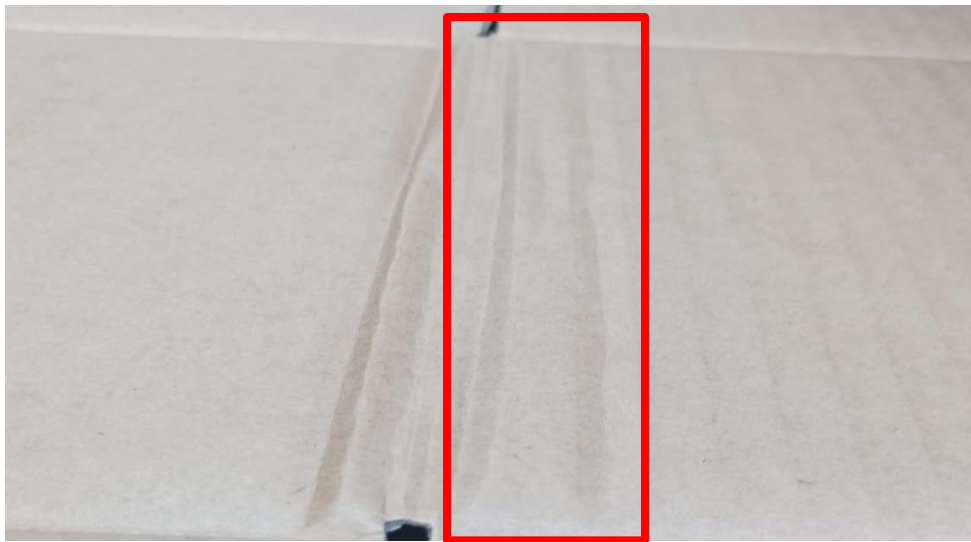
THERE IS A BUMP (BULGED) BESIDE THE FOLDING LINE

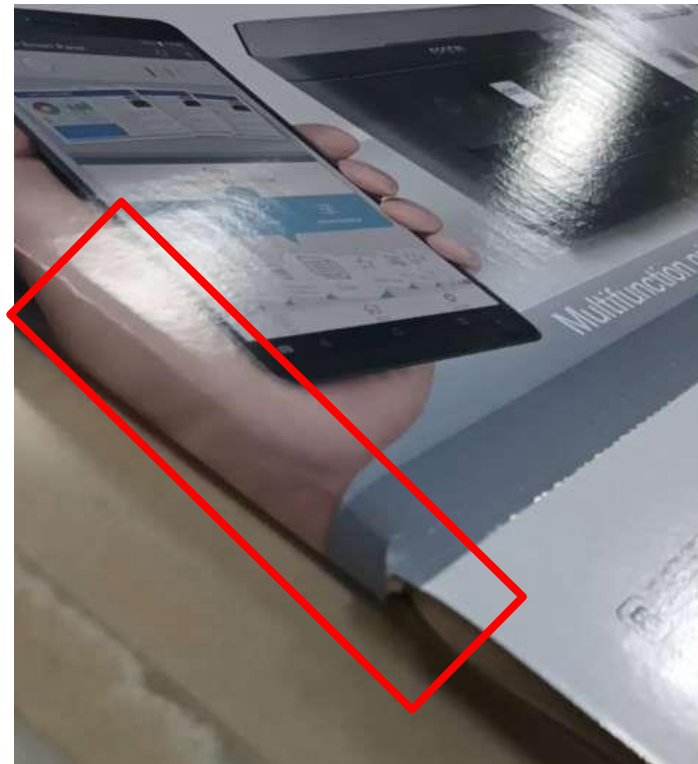
CRITERIA OF INSPECTION OF CUSHION CREASE (INCLUDED IN TOOLING CHECKSHEET)

THE OUTSIDE APPEARANCE OF FOLDING SIDE IS THICK
