**KANEPACKAGE PHILIPPINE INC.**

**INVESTIGATION REPORT**

<b>1.1. ISSUE:</b>	
	TEAR OFF
<b>1.2. ITEM DESCRIPTION:</b>	
<b>PART CODE:</b>	5165877-00 / 5165878-00
<b>PART NAME:</b>	LIONEL 2 MBL
<b>1.3. BACKGROUND:</b>	
<b>PICTURE</b>	<b>DETAILS:</b>

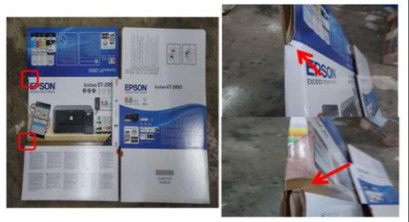
<p>In-house Detection : TEAR OFF            Lot size : 2983pcs            Reject Qty : 313pcs            Rejection Rate : 10.49%</p>

ACTION ITEMS	Target Date:	Person In-charge
OPERATOR INFORM THE IN LINE QA REGARDING THE TEAR OFF & SORT THE AFFECTED ITEMS	230915	OPERATOR

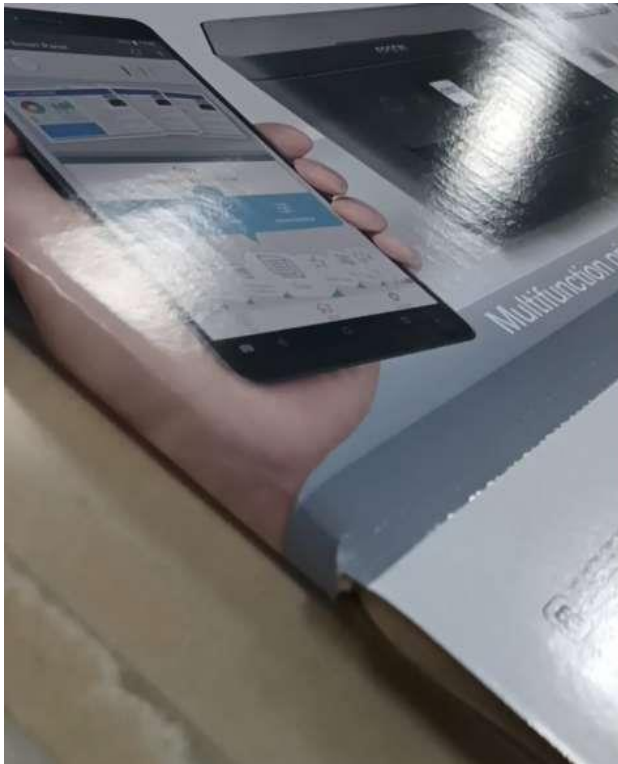
THE OUTSIDE APPEARANCE OF  
FOLDING SIDE IS THICK

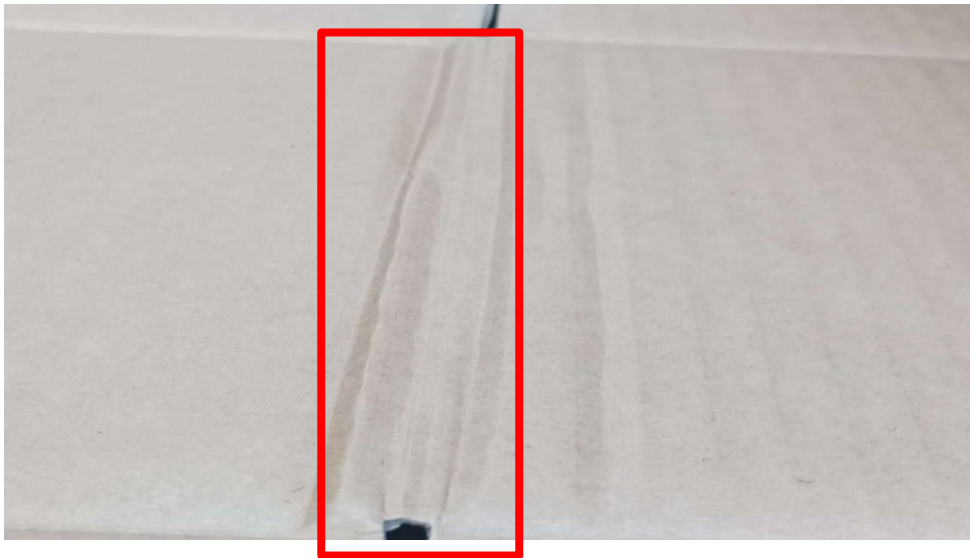
<b>WHY 1:</b>	Tear off occurred when the glued panels was being folded at semi auto gluing process
<b>WHY 2:</b>	The glued box was folded not in his original folding line
<b>WHY 3:</b>	There is bumped or bulging on the inner part of the box beside the Folding line resulting a strong tension on the horizontal Folding line
<b>WHY 4:</b>	Wrong and over backing of tape mounted on the creasing line
<b>WHY 5:</b>	Putting backing tape on the creasing line in the pattern sheet will cause additional pressure resulted to TEAR OFF

THERE IS A BUMP (BULGED) BESIDE THE FOLDING LINE

1	ORIENTATION FOR TOOLING CUSTODIAN AND DIECUT OPERATOR REGARDING TEAR OFF ENCOUNTERED.	TARGET DATE :230916 PIC: IE STAFF
2	TIGHTENING THE CHECKING OF THE PATTERN SHEET DURING SET UP.	TARGET DATE :230916 PIC: SUBLEADER
3	PROPER USE OF BACKING TAPE.	TARGET DATE : NEXT RUNNING OF LIONEL ITEM PIC: OPERATOR/SUBLEADER
