<b>KANEPACKAGE PHILIPPINE INC.</b> No. 5 Ring Road LISP II, Brgy. La Mesa, Calamba City, Laguna Telephone No. (049) 545-7166 to 69 Fax No. (049) 545-6302	<b>INVESTIGATION REPORT</b>		
	Prepared By:	Check By:	Approved By:
	MHVITO QA-IE/ Prodn IE	N. CEPEDA QA/ Prodn SV	R. MIRANDA KPLIMA Operations Gen. Mngr.
<b>DATE:</b>	230921

<b>1.1. ISSUE:</b>	
	DELAMINATION
<b>1.2 DETAIL</b>	
<b>PART CODE:</b>	5163364-00
<b>PART NAME:</b>	SOUFFLE CARTON BOX
<b>1.3. BACKGROUND:</b>	
<b>PICTURE</b>

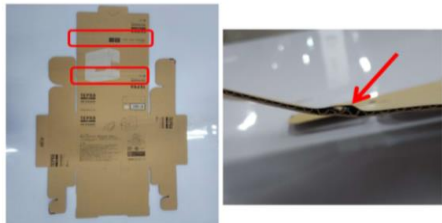
<b>DETAILS:</b> > LOT QTY: 347EA > REJECT QTY: 272EA > VISCOSITY: 10.1 > GLUE TYPE: WHITE GLUE > DETECTION: DIE CUT PROCESS

<b>WHY 1:</b>	DELAMINATION ENCOUNTER ON TH E ITEM 5163364-00 SOUFFLE CARTON BOX DETECTED AT DIE CUT PROCESS.
<b>WHY 2:</b>	SOME PART OF CURROGATED MEDIUM OF THE SINGLE FACE WAS FLATTEN WHILE RUNNING AT LAMINATION THAT RESULT AN INSUFFICIENT APPLICATION OF GLUE.
<b>WHY 3</b>	THE LEFT PORTION OF RUBBER ROLLER CAME DOWN DURING FEEDING OF SINGLE FACE.
<b>WHY 4:</b>	THE ADJUSTER SCREW OF THE RUBBER ROLLER ACCIDENTALLY LOOSE.
<b>WHY 5:</b>	RUBBER ROLLER WAS NOT CHECK BY OPERATOR PRIOR MACHINE SET-UP. NOTE: CHECKING OF RUBBER ROLLER NOT INDICATE ON DMC.

1	ORIENTATION TO LAMINATION OPERATOR REGARDING DELAMINATION ISSUE FOR THE ITEM 5163364-00 SOUFFLE CARTON BOX	230921
2	INCLUSION OF RUBBER ROLLER AT DMC AND WI FOR THEIR ADDITIONAL CHECKPOINT.	230929
