KANEPACKAGE PHILIPPINE INC. No. 5 Ring Road LISP II, Brgy. La Mesa, Calamba City, Laguna Telephone No. (049) 545-7166 to 69 Fax No. (049) 545-6302	<h1>INVESTIGATION REPORT</h1>		
	Prepared By:	Check By:	Approved By:
DATE:	230927	MHVITO QA-IE/ Prodn IE	N. CEPEDA QA/ Prodn SV
		R. MIRANDA KPLIMA Operations Gen. Mngr.

1.1. ISSUE:	
	MISALIGNED GLUING (MISALINGED PS VS SF)
1.2 DETAIL	
PART CODE:	5161066-00
PART NAME:	ROSA SAX ICB FOR INDONESIA
1.3. BACKGROUND:	
PICTURE

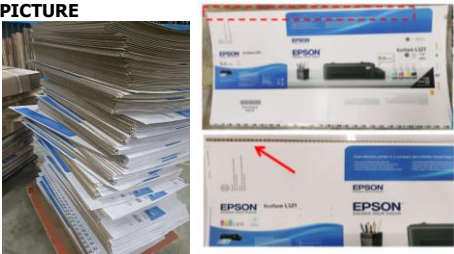
DETAILS: <ul style="list-style-type: none"> > MISALIGNED PANEL A > PLAN QTY: 2000 EA > REJECT QTY: 238 EA > REJECT PERCENTAGE: 11.90% > JO ORDER: 45588

WHY 1:	MISALIGNED GLUING (MISALINGED PS VS SF) WITH ITEM CODE 5161066-00 ROSA SAX ICB FOR INDONESIA ENCOUNTERED AT LAMINATION PROCESS.
WHY 2:	DURING MASS PRODUCTION, CATCHER OPERATOR NOTICE THAT THE PANEL A HAS MISALINGED GLUE. UPON CHECKING OF THE PROCESS, THE GREEN BELT AT THE LEFT SIDE WAS NOT WORKING (STUCK-UP) / NOT CONTINUOUSLY ROTATING.
WHY 3	THE RED BELT AT THE LEFT SIDE THAT CONNECT TO THE GREEN BELT WAS LOOSE (STRETCHED) THAT RESULT DELAY FEEDING OF PRINTED SHEET.
WHY 4:	TOO MUCH USED OF RED BELT. <i>NOTE: NO LIFE SPAN OF USAGE FOR RED BELT</i>

ACTION ITEMS	Target Date:	Person In-charge
SORTING OF ITEM	230926	PRODUCTION/QA
REDUCE SPEED TO AVOID DELAY FEEDING OF PS	230926	PRODUCTION

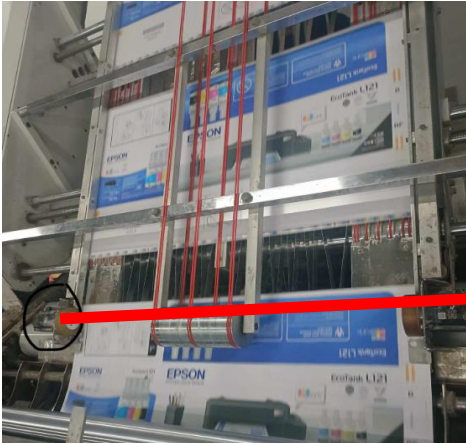
BEFORE

STUCK-UP GREEN-RED BELT AT LEFT SIDE OF PS FEEDER

1	CONDUCT MEETING/ ORIENTATION REGARDING TO THE ISSUE OF MISALIGEND GLUE AT ITEM 5161066-00 ROSA SAX ICB FOR INDONESIA.	230926
2	REQUEST REPAIR OF GREEN/RED BELT STUCK-UP TO ENGINEERING	230927
3	CONDUCT STUDY FO THE LIFE SPAN OF THE RED BELT	ONGOING
