<b>KANEPACKAGE PHILIPPINE INC.</b> No. 5 Ring Road LISP II, Brgy. La Mesa, Calamba City, Laguna Telephone No. (049) 545-7166 to 69 Fax No. (049) 545-6302	<h1>INVESTIGATION REPORT</h1>		
	Prepared By:	Check By:	Approved By:
	MHVITO	N. CEPEDA/R.ALMARIO	R. MIRANDA
<b>DATE:</b>	231010	QA-IE/ Prodn IE	QA/ Prodn SV/MANAGER
		KPLIMA ASST.VICE PRESIDENT

<b>1.1. ISSUE:</b>	
	PEEL OFF
<b>1.2 DETAIL</b>	
<b>PART CODE:</b>	516590200
<b>PART NAME:</b>	LOUVRE 2 MDX
<b>1.3. BACKGROUND:</b>	
<b>PICTURE</b>

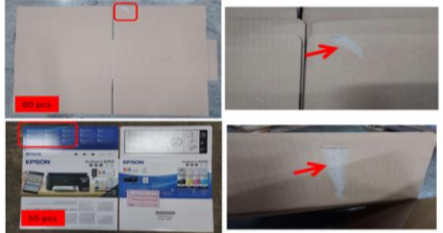
<b>DETAILS:</b>  > PLAN QTY: 895 EA > REJECT QTY: 66 EA > REJECT PERCENTAGE: 7.37%

ACTION ITEMS	Target Date:	Person In-charge
PUTTING PAPER TAPE AT FEEDER BELT

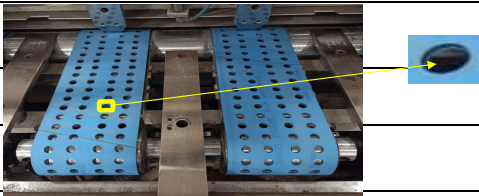
<b>WHY 1:</b>	<b>Why Peel Off occurred in Louvre item?</b> It was hardly scrubbed by the feeder belt during lamination process

<b>WHY 2:</b>	<b>Why Scrubbing by the Feeder Belt causes Peel Off?</b> Feeder Belt has a sharp edges and rough surface particular on the hole area	
<b>WHY 3:</b>	<b>Why Feeder Belt has a sharp edges and rough texture?</b> Feeder belt installed in the feeding section is New	
<b>WHY 4:</b>	<b>Why New Feeder Belt with a Sharp edges and Rough Texture installed in the machine?</b> Current Feeder Belt installed was Old and Deteriorated already	
<b>WHY 5:</b>	-

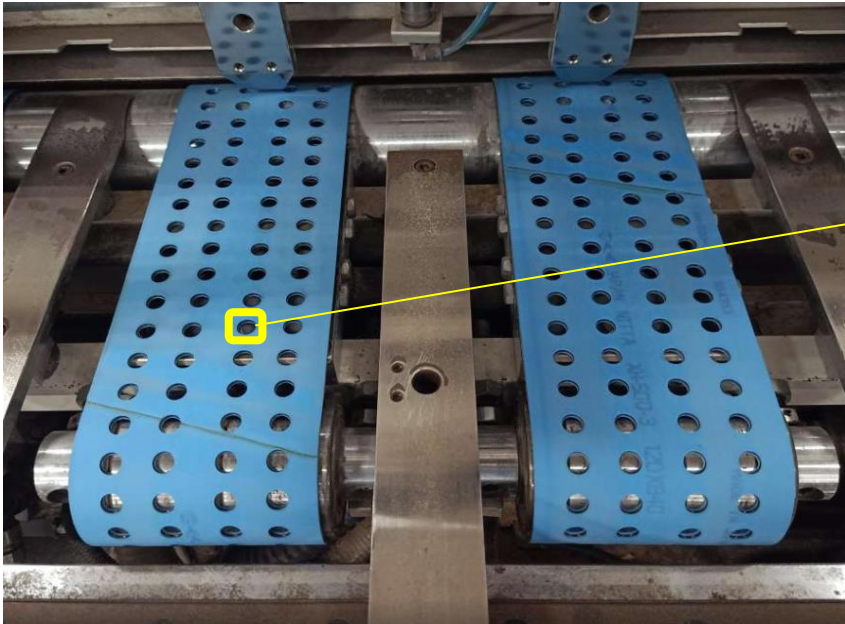
SHARP EDGE
