KANEPACKAGE PHILIPPINE INC. No. 5 Ring Road LISP II, Brgy. La Mesa, Calamba City, Laguna Telephone No. (049) 545-7166 to 69 Fax No. (049) 545-6302	<h1>INVESTIGATION REPORT</h1>		
	Prepared By:	Check By:	Approved By:
	MHVITO QA-IE/ Prodn IE	N. CEPEDA/R.ALMARIO QA/ Prodn SV/MANAGER	R. MIRANDA KPLIMA ASST.VICE PRESIDENT
DATE:	231010

1.1. ISSUE:	
	GLUE STAIN
1.2 DETAIL	
PART CODE:	5162982-00
PART NAME:	LOUVRE 2 MCX ICB FOR ASIA
1.3. BACKGROUND:	
PICTURE

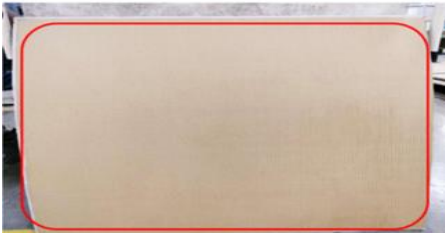
DETAILS: <ul style="list-style-type: none"> > PLAN QTY: 2000PCS > REJECT QTY: 68 PCS > REJECT PERCENTAGE: 3.4%

WHY'S	DETAIL	IMAGE
WHY 1:	Why Glue stain occurred in Louvre item? The glue leak on the water roller.

WHY 2:	Why Glue Leak on the Water Roller? Glue roller has scrap during running of mass production.

WHY 3	Why Glue roller has Scrap? The Single Face used has Scrap came from the supplier.

KANEPACKAGE PHILIPPINE INC. No. 5 Ring Road LISP II, Brgy. La Mesa, Calamba City, Laguna Telephone No. (049) 545-7166 to 69 Fax No. (049) 545-6302		<h1>INVESTIGATION REPORT</h1>		
		Prepared By:	Check By:	Approved By:
DATE:	231010	MHVITO QA-IE/ Prodn IE	N. CEPEDA/R.ALMARIO QA/ Prodn SV/MANAGER	R. MIRANDA KPLIMA ASST.VICE PRESIDENT
WHY 4:	Why Single face has Scrap came from the supplier? Supplier deliver the raw material with uncut trimmings.

ACTION ITEMS	Target Date:	Person In-charge
SORTING OF ITEM	231010	PRODUCTION/QA
REMOVE SCRAP ON THE ROLLER

1	CONDUCT MEETING/ ORIENTATION REGARDING TO THE ISSUE OF GLUE STAIN AT ITEM CODE 5162982-00 LOUVRE 2 MCX ICB FOR ASIA

231010
2	FEEDBACK TO SUPPLIER THE SCRAP ISSUE ON SF		ALREADY COORDINATE TO QA
3	Inclusion of checking of Glue roller at Feeder area while putting of board in Work instruction
