KANEPACKAGE PHILIPPINE INC. No. 5 Ring Road LISP II, Brgy. La Mesa, Calamba City, Laguna Telephone No. (049) 545-7166 to 69 Fax No. (049) 545-6302	<h1>INVESTIGATION REPORT</h1>		
	Prepared By:	Check By:	Approved By:
	K.DIAZ QA-IE/ Prodn IE	N. CEPEDA QA/ Prodn SV	R. MIRANDA KPLIMA Operations Gen. Mngr.
DATE:	OCTOBER 17, 2023

1.1. ISSUE:	
	TEAR OFF
1.2. ITEM DESCRIPTION:	
PART CODE:	516336400 / 516728200
PART NAME:	MUFFRIN / FRANZ
1.3. BACKGROUND:	
PICTURE

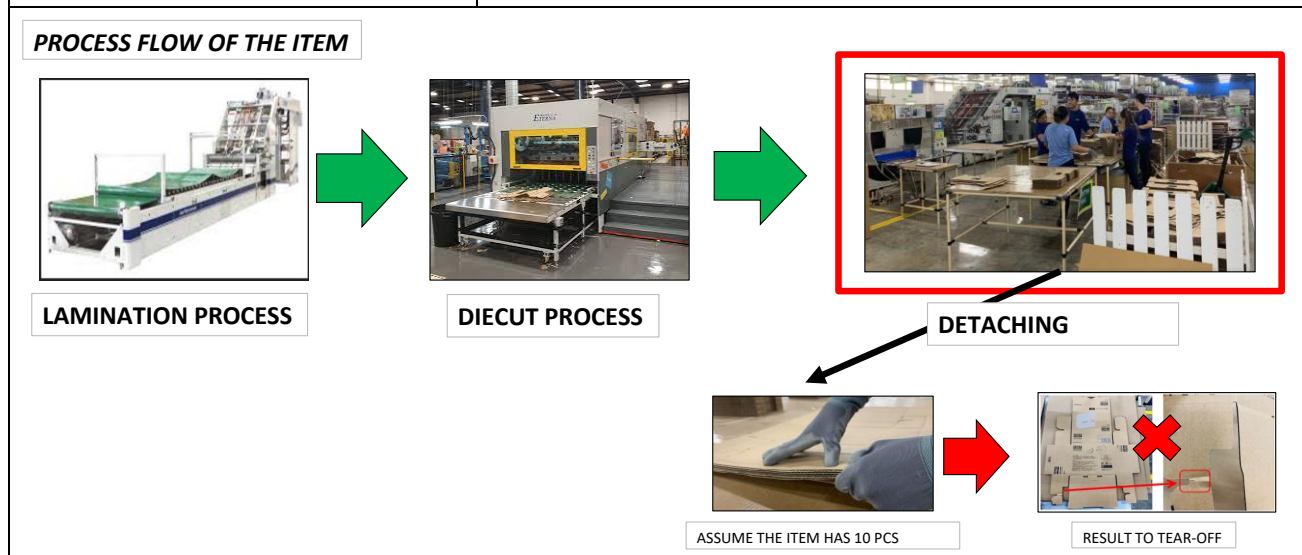
DETAILS: > Inhouse Detection : TEAR OFF > Lot size: 691pcs > Reject Qty: 70pcs > Rejection Rate: 10.13%

WHY 1:	WHY TEAR-OFF OCCURRED ON THE ITEM? TEAR-OFF OCCURRED AS A RESULT OF THE OPERATOR'S WAY TO DETACH THE ITEM DURING THE DETACHING PROCESS.

ACTION ITEMS	Target Date:	Person In-charge
RE-EDUCATE THE OPERATORS FOR PROPER WAY OF DETACHING ITEMS	231025	PIC: OPERATOR AND SUBLEADER
