KANEPACKAGE PHILIPPINE INC. Blk 6-B Lot 2 & 3 P3, Lima Technology Center, Malvar, Batangas Telephone No.: (043) 236-6885	INVESTIGATION REPORT		
	Prepared By:	Check By:	Approved By:
	MHVITO QA-IE/ Prodn IE	N. CEPEDA/R.ALMARIO QA/ Prodn SV/MANAGER	R. MIRANDA KPLIMA ASST.VICE PRESIDENT
DATE:	231020

I. PROBLEM DESCRIPTION

1.1. ISSUE:	
	WRONG SLOT
1.2 DETAIL	
PART CODE:	5150863-01
PART NAME:	OUTER CARTON BOX
1.3. BACKGROUND:	
PICTURE

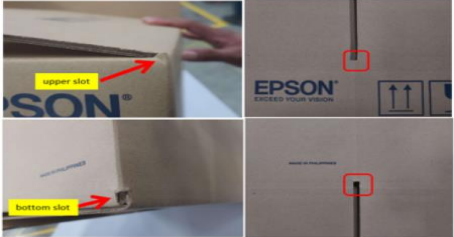
DETAILS: <ul style="list-style-type: none"> > PLAN QTY:1240 EA > REJECT QTY: 400 EA > REJECT PERCENTAGE: 32.26%

WHY 1:	Why Wrong Slot occurred in Outer Carton Box item? Overhang cutting Slot of EQOS mis-slot the lower part of the box
WHY 2:	Why the lower part of the box mis slotted? Corrugated Board moved when it was passed on the Feed Gripper Roller
WHY 3:	Why corrugated board moved when passed in the feed Gripper roller? The Feed Gripper roller was holding the sheets by 10mm only instead of 20mm
WHY 4:	Why the Feed Gripper Roller Holding the sheets too small? (10m)? To avoid the print images hit by the roller

1	CONDUCT MEETING/ ORIENTATION REGARDING TO THE ISSUE OF WRONG SLOT ON THE ITEM 5150863-01 OUTER CARTON BOX

231016
2	ADJUSTMENT ON FEED ROLLER GRIPPER FROM 897mm TO 887mm GUIDED BY THE UMETANI JAPANESE TECHNICIAN

231016
3	FOLDING OF ITEM INTO BOX FORM FOR ADDITIONAL CHECK POINT ON THE CUTTING SLOT DURING SAMPLING	 	231020
