KANEPACKAGE PHILIPPINE INC. No. 5 Ring Road LISP II, Brgy. La Mesa, Calamba City, Laguna Telephone No. (049) 545-7166 to 69 Fax No. (049) 545-6302	<h1>INVESTIGATION REPORT</h1>		
	Prepared By:	Check By:	Approved By:
	MHVITO QA-IE/ Prodn IE	N. CEPEDA/R.ALMARIO QA/ Prodn SV/MANAGER	R. MIRANDA KPLIMA ASST.VICE PRESIDENT
DATE:	231103

1.1. ISSUE:	
	MISALIGNED GLUING
1.2 DETAIL	
PART CODE:	5167869-00
PART NAME:	LOUVRE 2 MJX EUROPE
1.3. BACKGROUND:	
PICTURE

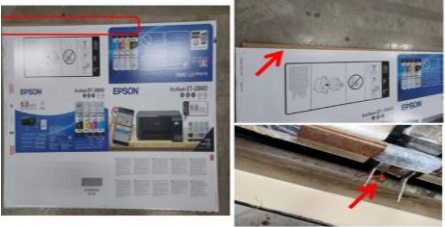
DETAILS: <ul style="list-style-type: none"> > PLAN QTY: 2000PCS > REJECT QTY: 131 PCS > REJECT PERCENTAGE: 6.55%

WHY'S	DETAIL	IMAGE
WHY 1:	Why misaligned gluing occurred in Louvre item? The Printed Sheet and Single face are delay in feeding

WHY 2:	Why Single face and Printed sheet are delayed in feeding? The sensor had fiber or scrap trimming of paper

WHY 3	Why Sensor has Scrap? The Single Face used has Scrap came from the supplier.

Why Single face has Scrap came from the supplier?
Supplier deliver the raw material with uncut trimmings.

ACTION ITEMS	Target Date:	Person In-charge
PUSH EMERGENCY STOP AND SORTING OF ITEM	231027	PRODUCTION
REMOVE FIBER ON THE ROLLER

231027
2	FEEDBACK TO SUPPLIER THE SCRAP ISSUE ON SF		ALREADY COORDINATE TO QA
3	Inclusion of checking of Sensor before and after Job in Work instruction
