KANEPACKAGE PHILIPPINE INC. No. 5 Ring Road LISP II, Brgy. La Mesa, Calamba City, Laguna Telephone No. (049) 545-7166 to 69 Fax No. (049) 545-6302	<h1>INVESTIGATION REPORT</h1>		
	Prepared By:	Check By:	Approved By:
	MHVITO QA-IE/ Prodn IE	N. CEPEDA/R.ALMARIO QA/ Prodn SV/MANAGER	R. MIRANDA KPLIMA ASST.VICE PRESIDENT
DATE:	231116

1.1. ISSUE:	
	PEEL OFF
1.2 DETAIL	
PART CODE:	5161818-00
PART NAME:	LINUS FAL AMERICA
1.3. BACKGROUND:	
PICTURE

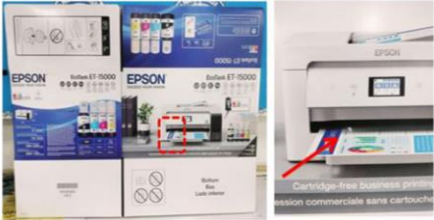
DETAILS: > PLAN QTY: 199 EA > REJECT QTY: 45 EA > REJECT PERCENTAGE: 22.61%

WHY 1:	Why Peel Off occurred in LINUS item? The panels has glue stain on the board prior to die cut.
WHY 2:	Why Glue stain occurred at boards? The scrap left on the glue roller that spill on boards
WHY 3	Why they have scrap on the glue roller? The boards used has small trimmings of fiber prior issuance.
WHY 4:	Why small trimming of fiber occurred? Raw material issued by the supplier has fiber.
WHY 5:	-

ACTION ITEMS	Target Date:	Person In-charge
Cleaning of glue roller	231116	PRODUCTION

1	Conduct Orientation regarding to the issue of Peel Off on the item 5161818-00 Linus Fal America

231116
2	Feedback to supplier the scrap issue
