Investigation Report for Misalign Print of Kowa-Emori HP33D1057-1 & HP33D1010-1 Carton Box

CONTROL No:	IRF - 699 & 701			REJECT PERCENTAGE:	3.36%
REJECT QTY:	151	LOT QTY:	4500

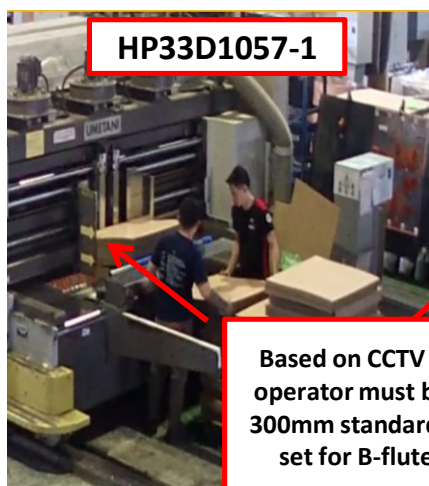
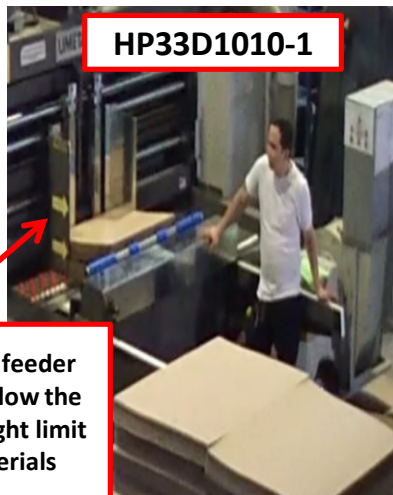
Based on CCTV Eqos feeder operator must be follow the 300mm standard height limit set for B-flute materials

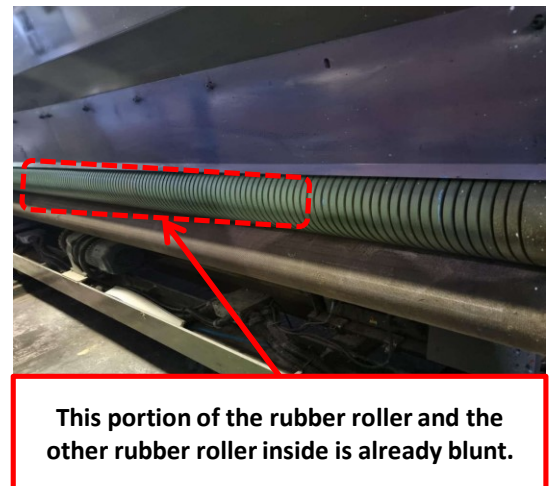
DIRECT CAUSE	W1	There's a factor that the cause of misalign print is the blunt middle portion of rubber roller in the Eqos Feeder Unit.
	W2	Possible that the sheets got slightly delay in feeding if the piled of materials hit the standard height limit.
	W3	As of now the weight of piled materials in feeder have impact in misalign print since the feeder rubber roller is blunt in the middle portion.

This portion of the rubber roller and the other rubber roller inside is already blunt.

Conduct further study to reduce the standard height limit per flute temporarily and reduce the vacuum power as sir Suzuki's recommendation while the blunt rubber roller has not been replaced.	PIC:	Production Leaders & IE	TARGET DATE:	231026
---	------	-------------------------	--------------	--------
