Investigation Report for Misalign Glue of Kowa Emori HP33D1057-1 Carton Box

CONTROL No:	IRF - 718			REJECT PERCENTAGE:	3.60%
REJECT QTY:	36	LOT QTY:	1000

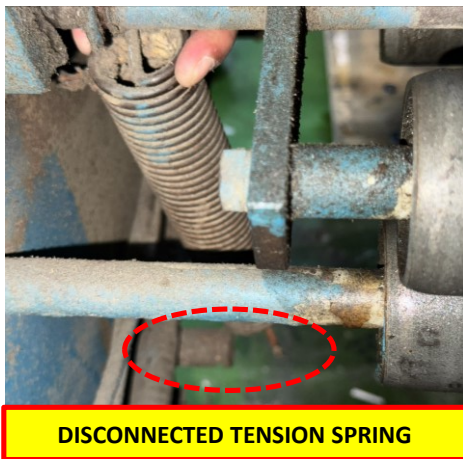
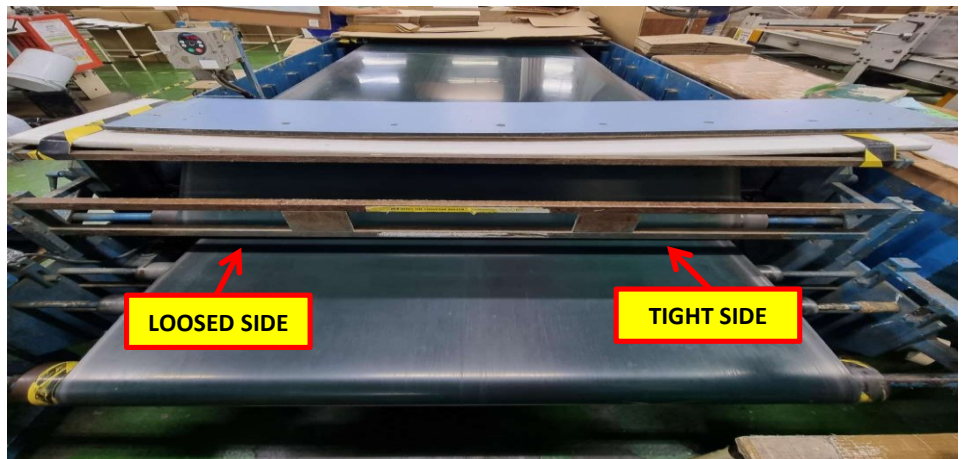
DIRECT CAUSE	W1	Based on investigation the operator encounter misalign gluing frequent on the left side of the conveyor.
	W2	Upon checking the tension of the conveyor on the left and right side is not equal.
	W3	Conveyor tension is loosed on the left side compared to the right side.
	W4	Upon checking under the machine one of the tension springs on the left side was disconnected that caused loosed tension on the left side of the conveyor.
	W5	The loosed tension on the left side of conveyor is the factor that may caused misalign glue.

Reconnect the tension spring and adjust equally the tension of left and right side of conveyor.	PIC:		TARGET DATE:	
---	------	--	--------------	--

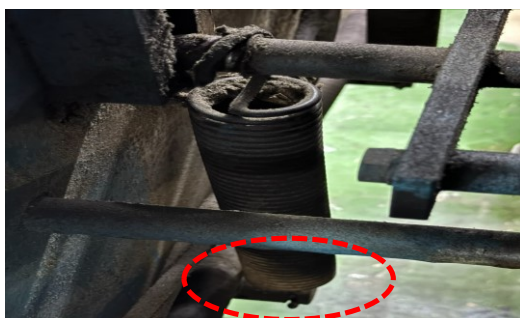
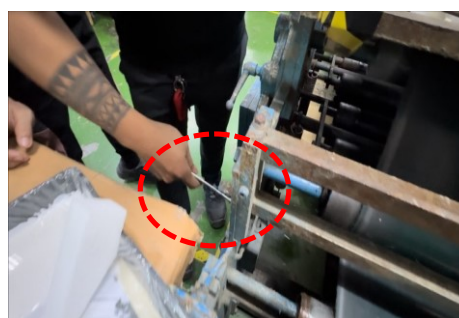
TENSION SPRING ALREADY RECONNECTED AND THE TENSION OF CONVEYOR ON THE LEFT & RIGHT SIDE ALREADY EQUAL
