INVESTIGATION REPORT

DATE: JANUARY 10, 2024

1.1. ISSUE: PEEL OFF

1.2. ITEM DESCRIPTION:
 PART CODE: 5151436-00
 PART NAME: CARTON BOX STD;B

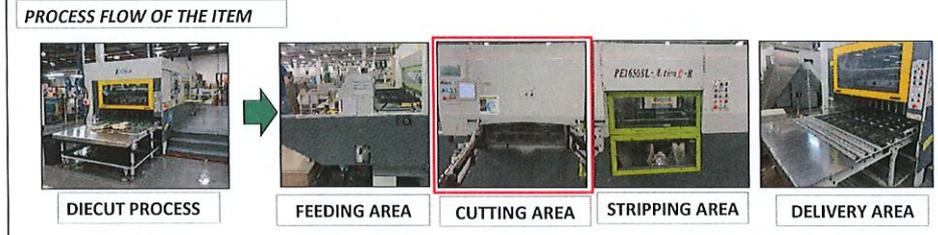
PICTURE

- > Inhouse Detection : PEEL OFF
- > Lot size: 299pcs
- > Reject Qty: 15pcs
- > Rejection Rate: 5.01%

WHY 1:	Why there are PEELED OFF defect in 5151436-00 ICB? There is an un-cut part on the box that causes the Top sheet un-detached

WHY 2:	Why There is an un-cut part on the box that causes the Top sheet un-detached? There is un-balance pressure applied on the process resulting un balance cutting	
WHY 3:	Why there is un-balance pressure applied on the process resulting un balance cutting? Deteriorated Pattern Sheet with deteriorated and wron out backing Tape	
WHY 4:	Why there is a Deteriorated Pattern Sheet with deteriorated and wron out backing Tape? No Proper and Standard monitoring the life span of Pattern Sheet

ACTION ITEMS	Target Date:	Person In-charge
1. PUT BACKING TAPE ON THE UNCUT PORTION 2. THE SUBLEADER OF SEMI AUTO INFORMED THE SUBLEADER OF DIECUT THAT AN UNCUT WAS FOUND. THE SUBLEADER EDUCATES HIS OPERATOR ON MANUAL BROWSING AND INFORMS THE LEADER AND SENIOR OPERATOR ON ANY ABNORMALITIES ENCOUNTERED.	JANUARY 10, 2024	PIC: OPERATOR AND SUBLEADER

1	>RE-EDUCATE THE OPERATORS FOR TIGHTENING THE MANUAL BROWSING AND INFORM THEIR SUBLEADER OR SENIOR OPERATOR FOR ANY ABNORMALITIES BEING ENCOUNTERED. >MANUAL DETACHING OPERATOR MUST INFORM DIECUT REGARDING UNCUT PARTS.

PIC: IE STAFF/LINELEADER/OPERATOR TARGET DATE: JANUARY 10, 2024
2	Study and Set Life Span monitoring of Pattern Sheet	PIC: IE STAFF/LINELEADER/OPERATOR TARGET DATE: JANUARY 12, 2024
