Investigation Report for Misalign Glue of Kowa Emori HP01D2000-3 Carton Box

CONTROL No:	IRF - 724			REJECT PERCENTAGE:	3.00%
REJECT QTY:	270	LOT QTY:	9000

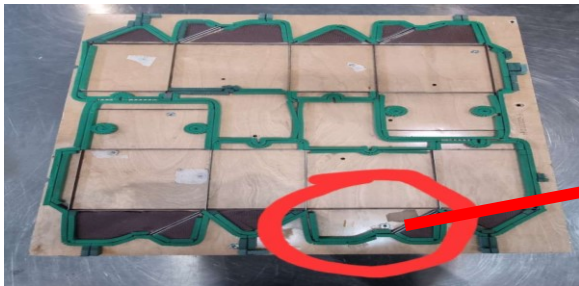
DIRECT CAUSE	W1	No problem in 1st gluing process and during 2nd gluing process the lower flap alignment is uncontrolled upon feeding in Conveyor.
	W2	Upon checking of die-blade there's a portion on lower flap don't have brown sponge to pressed that portion during Eterna process.
	W3	Possible the operator removed the brown sponge because there is a screw nuts on that portion.
	W4	The un-pressed portion is the factor of misalign gluing or cannot fit lock since upon checking of affected only the cavity 1 is affected

<p>All the remaining wip for Gluing suggested the 2nd Gluing process on conveyor 1 because it will pressed the items more, compared to SD1800 where the affected run.</p> <p>Note: Before the suggestion we conduct trial in Conveyor 1 and no misalign glue or cannot fit lock occurs.</p>		PIC:	Gerald De Guzman	TARGET DATE:	240122
<p>Put Brown sponge in the affected portion and orient the operator regarding the technique if the screw nuts cover by sponge.</p>		PIC:	Gerald De Guzman	TARGET DATE:	240122
