<b>KANEPACKAGE PHILIPPINE INC.</b> No. 5 Ring Road LISP II, Brgy. La Mesa, Calamba City, Laguna Telephone No. (049) 545-7166 to 69 Fax No. (049) 545-6302	<h1>INVESTIGATION REPORT</h1>		
	Prepared By:	Check By:	Approved By:
	K.DIAZ QA-IE/ Prodn IE	N. CEPEDA QA/ Prodn SV	R. MIRANDA KPLIMA Operations Gen. Mngr.
<b>DATE:</b>	NOVEMBER 20, 2023

<b>1.1. ISSUE:</b>	
	MISALIGN CUT
<b>1.2. ITEM DESCRIPTION:</b>	
<b>PART CODE:</b>	516554600
<b>PART NAME:</b>	CARTON BOX
<b>1.3. BACKGROUND:</b>	
<b>PICTURE</b>

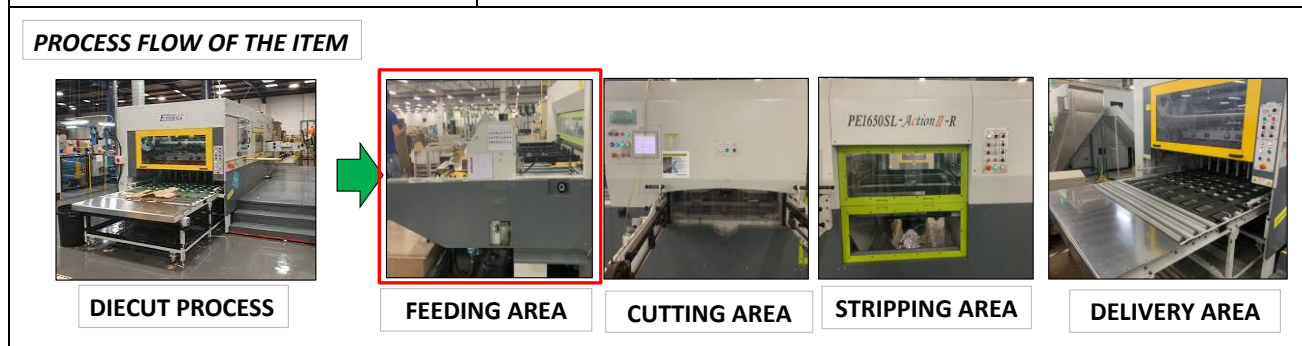
<b>DETAILS:</b> >Inhouse Detection : MISALIGN CUT >Lot size: 378pcs > Reject Qty: 58pcs >Rejection Rate: 15.34%

<b>WHY 1:</b>	<b>WHY MISALIGN CUT OCCURRED ON THE ITEM?</b> A MISALIGN CUT OCCURRED IN THE FEEDING SECTION DUE TO ITEM CONDITION (MISALIGN GLUING).

<b>WHY 2:</b>	<b>WHY THE CONDITION OF ITEM HAS MISALIGN GLUING?</b> DURING PROCESSING THE OPERATOR ENCOUNTERED EXCESS SINGLE FACE IN THE ITEM.

DURING LAMINATION PROCESS, THEY ENCOUNTERED DELAY FEEDING OF SINGLE FACE AND INSTEAD OF PRINTED SHEETS, THE SIDE GUIDE PUSHES THE SINGLE FACE.

THE SENSOR HAD FIBER OF PAPER.

ACTION ITEMS	Target Date:	Person In-charge
THE SUBLEADER OF DIECUT INFORM THE SUBLEADER OF LAMINATION THAT THE ITEM HAS EXCESS SF IN THE ITEM.		PIC: OPERATOR AND SUBLEADER

1	CONDUCT A MEETING AND RE-EDUCATE THE OPERATORS ABOUT THE ISSUE AND TIGHTENING OF MANUAL BROWSING OF AN ITEM.	PIC: IE STAFF/LINELEADER/OPERATOR TARGET DATE: NOV 20, 2023
2	IF ENCOUNTERED EXCESS SINGLE FACE, SORT AND REWORK THE ITEM.	PIC: SUBLEADER/OPERATOR TARGET DATE: NOV 20, 2023
