KANEPACKAGE PHILIPPINE INC. No. 5 Ring Road LISP II, Brgy. La Mesa, Calamba City, Laguna Telephone No. (049) 545-7166 to 69 Fax No. (049) 545-6302	<h1>INVESTIGATION REPORT</h1>		
	Prepared By:	Check By:	Approved By:
	K. DIAZ QA-IE/ Prodn IE	N. CEPEDA QA/ Prodn SV	R. MIRANDA KPLIMA Operations Gen. Mngr.
DATE:	NOVEMBER 20, 2023

1.1. ISSUE:	
	MISALIGN CUT
1.2. ITEM DESCRIPTION:	
PART CODE:	516212703
PART NAME:	CARTON BOX
1.3. BACKGROUND:	
PICTURE

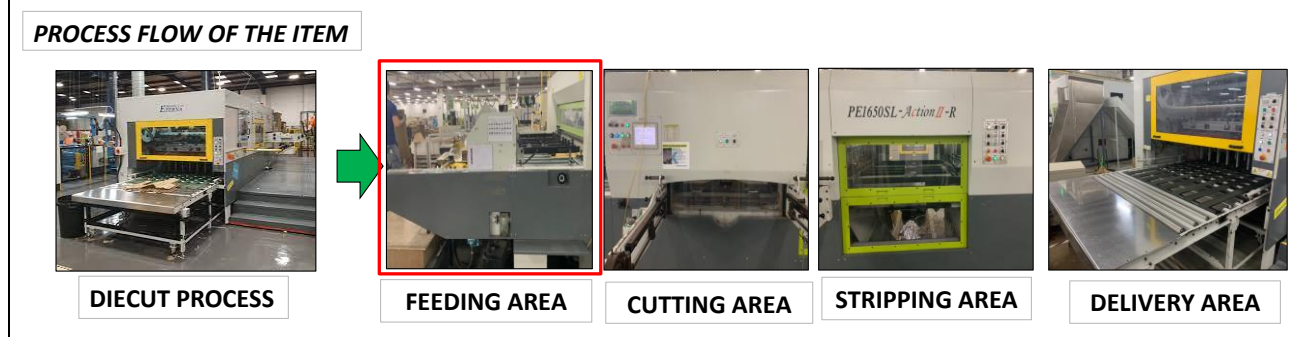
DETAILS: > Inhouse Detection : MISALIGN CUT > Lot size: 1721pcs > Reject Qty: 232pcs > Rejection Rate: 13.48%

WHY 1:	WHY MISALIGN CUT OCCURRED ON THE ITEM? A MISALIGN CUT OCCURRED IN THE FEEDING SECTION DUE TO ITEM CONDITION (MISALIGN GLUING).

WHY 2:	WHY THE CONDITION OF ITEM HAS MISALIGN GLUING? DURING PROCESSING THE OPERATOR ENCOUNTERED EXCESS SINGLE FACE IN THE ITEM.

DURING LAMINATION PROCESS, THEY ENCOUNTERED DELAY FEEDING OF SINGLE FACE AND INSTEAD OF PRINTED SHEETS, THE SIDE GUIDE PUSHES THE SINGLE FACE.

THE SENSOR HAD FIBER OF PAPER.

ACTION ITEMS	Target Date:	Person In-charge
THE SUBLEADER OF DIECUT INFORM THE SUBLEADER OF LAMINATION THAT THE ITEM HAS EXCESS SF IN THE ITEM.		PIC: OPERATOR AND SUBLEADER

1	CONDUCT A MEETING AND RE-EDUCATE THE OPERATORS ABOUT THE ISSUE AND TIGHTENING OF MANUAL BROWSING OF AN ITEM.	PIC: IE STAFF/LINELEADER/OPERATOR TARGET DATE: NOV 20, 2023
2	IF ENCOUNTERED EXCESS SINGLE FACE, SORT AND REWORK THE ITEM.	PIC: SUBLEADER/OPERATOR TARGET DATE: NOV 20, 2023
