| KANEPACKAGE PHILIPPINE INC. No. 5 Ring Road USF II, Bldg. 1A, Mesa, Cebu City, Lapu-Lapu Telephone No. (035) 545 7155 to 59 Fax No. (035) 546 6302 | INVESTIGATION REPORT | | |

| 1.1. ISSUE: | MIXED MODEL |
| PART NAME: | LOUVE 2 MDX ASIA |

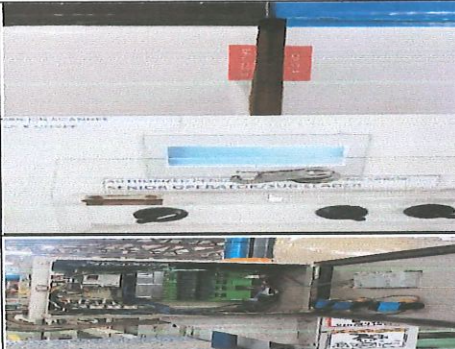
| WHY 1: WHY MIXED MODEL OCCURRED? OPERATOR DIDN'T NOTICE THAT THERE WAS A MIXED MODEL ENTERED DURING MASS PRODUCTION | |
| WHY 2: WHY OPERATOR DIDN'T NOTICE THE ENTRY OF THE MIXED MODEL? BARCODE SCANNER MALFUNCTION IN THE MIDDLE RUN OF MASS PRODUCTION AND THE OPERATOR FAILED TO UPDATE THE BARCODE ERROR | |
| WHY 3: WHY THE BARCODE SCANNER MALFUNCTION DURING MASS PRODUCTION? THE WIRE LOOSE INSIDE THE BARCODE SCANNER | |

| 1 | CONDUCT MEETING/ RE ORIENTATION REGARDING TO THE ISSUE OF MIXED MODEL | PIC: IE STAFF/LINELEADER/OPERATOR TARGET DATE: JANUARY 20, 2024 |
| 2 | REVISION OF WI TO INCLUDE THE FOLLOWING: FEEDER OPERATOR - UNLOADING OF ALL PANELS AT THE FEEDING AREA TO CHECK THE POSSIBLE ERROR FOLDER OPERATOR - SLIGHT LIFTING THE GLUED PANELS TO CHECK THE BARCODE OF BOTH PANELS - RELEASE ALL THE ITEMS INSIDE THE CONVEYOR CATCHER OPERATOR - CHECKING/BROWSING ALL THE GLUED ITEMS | PIC: IE STAFF/LINELEADER/OPERATOR TARGET DATE: FEBRUARY 2024 |
| 3 | STRENGTHEN IMPLEMENTATION OF UPDATING BARCODE ERROR IN PRODUCTION DAILY OUT MACHINE SET UP/ DOWNTIME | PIC: IE STAFF/LINELEADER/SUBLEADER/OPERATOR TARGET DATE: FEBRUARY 2024 |
