KANEPACKAGE PHILIPPINE INC.

INVESTIGATION REPORT

DELAMINATION

PART NAME: LOUVRE 2 MCX ICB FOR ET D,D

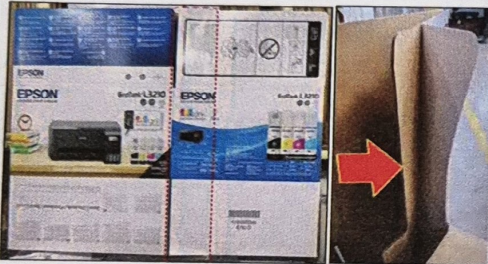
PICTURE

- > PLAN QTY: 957 EA
- > REJECT QTY: 85 EA
- > REJECT PERCENTAGE: 8.99%
- > JO ORDER: 10598

WHY 1:	Why Delamination occurred in Louvre item? The glue tab portion of the panel has insufficient glue application.	
WHY 2:	Why it has insufficient glue application? The sheet board and printed sheet does not adhere well even though it passes through the conveyor to flatten properly.	
WHY 3	Why glue applied on the SB does not adhere well on the Printed sheets? THE GLUE WAS NOT ENOUGH TO SUPPLY ON THE GLUE ROLLER CAUSE of malfunction of glue sensor

Glue sensor has accumulated glue which result to malfunction of the sensor.

No proper cleaning of glue sensor

1	ORIENT THE OPERATOR ON THE ISSUE OF DELAMINATION AT LOUVRE ITEM CAUSE BY LACKING OF GLUE SUPPLY		240322
2	CLEANING OF GLUE SENSOR EVERY START OF RUNNING JO INSTEAD OF END OF SHIFT		240412
3
