**KANEPACKAGE PHILIPPINE INC.**

**INVESTIGATION REPORT**

BURSTING

LOUVRE 2 (SF

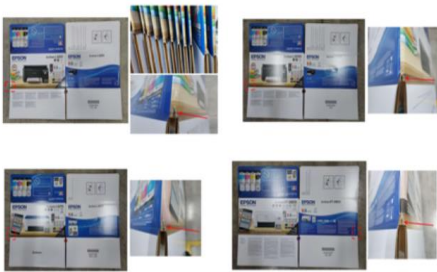
> Inhouse Detection : BURSTING  
> Lot size: 3758pcs  
> Reject Qty: 397pcs  
> Rejection Rate: 10.56%  
> JO#: 33732/33748/33750/33751

<b>WHY 1:</b>	Bursting occurred on the folding side and been detected during semi-auto gluing process. Note: Bursting was randomly encountered on the said affected part codes.
<b>WHY 2:</b>	Bursting occurred during diecut process since it was observed that the creasing blade is higher than the cutting blade. Note: Total of 397 bursting reject out of 3,758 pcs. input quantity.
<b>WHY 3:</b>	The creasing blade loose on the dieboard resulting from lifting of the creasing blade where bursting occurred. Note: During the machine set up, the tooling custodian did not notice that the creasing blade has sunk into the board which resulted to not being align due to the weakness of the board.

1	Checking and repair of the blade and Die blade Remarks: Sharpen the blade and trimming die plate if its needed. PIC: Tooling custodian Target Date: April 4, 2023	<b>*Still for monitoring*</b>
2	Checking of Creasing blade Note: New pattern sheet and cushion crease PIC: Sub-leader and operator Target: April 4, 2023
