KANEPACKAGE PHILIPPINE INC. No. 5 Ring Road LISP II, Brgy. La Mesa, Calamba City, Laguna Telephone No. (049) 545-7166 to 69 Fax No. (049) 545-6302	<h1>INVESTIGATION REPORT</h1>		
	Prepared By:	Check By:	Approved By:
	K. DIAZ	N. CEPEDA	R. MIRANDA
DATE:	230301	QA-IE/ Prodn IE	QA/ Prodn SV
		KPLIMA Operations Gen. Mngr.

1.1. ISSUE:	
BURSTING ENCOUNTERED ON THE FOLDING	
1.2. ITEM DESCRIPTION:	
PART CODE:	516297800
PART NAME:	LOUVRE 2 MDX ASIA
1.3. BACKGROUND:	
PICTURE

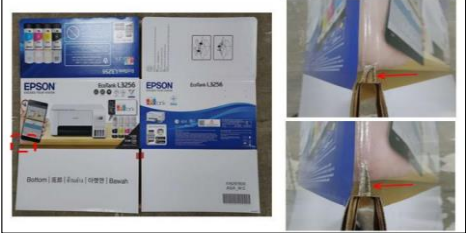
DETAILS: > Inhouse Detection : Bursting > Lot size: 768pcs > Reject Qty: 96pcs > Rejection Rate: 12.50% > JO#: 31277

WHY 1:	Bursting occurred on the folding side of the item upon gluing process.
WHY 2:	During folding process, folder operator chased the creasing line of the item in the 2nd gluing. Note: Folder in-charge encountered wide gap so they rubdown to met the standard gap of 8±2mm.
WHY 3:	While chasing and rubbing down the creasing line to met the standard gap, folder in-charge failed to observed occurrence of bursting defect which accumulates due to improper folding and creates tension during folding.
WHY 4:	Improper folding was due to bulging or bloated condition on the creasing area.
WHY 5:	Diecut process used eperan instead of cushion crease. Note: The benefit of using cushion crease was to improved productivity by reducing the difficulty of aligning the boards prior feeding to conveyor and to lessen encountered rejects such as bursting and tear off.

1	Conduct an orientation to operators regarding the bursting encountered on Louvre SF.	*Please see attached on next sheet*
---	--	-------------------------------------

2	Return the standard usage of cushion crease for Louvre SF model.	Target Date: March 1 running of Louvre SF PIC: Tooling/ Diecut Sub-leader
3	Monitor 3 consecutive running using cushion crease for the possible recurrence of bursting.	Target Date: March 1 running of Louvre SF PIC: Production IE
