**KANEPACKAGE PHILIPPINE INC.**

**INVESTIGATION REPORT**

DELAMINATION

**1.2. ITEM DESCRIPTION:****PART CODE:** 515639001**PART NAME:** CARTON BOX**1.3. BACKGROUND:**

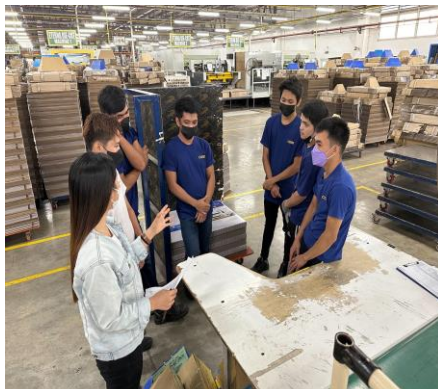
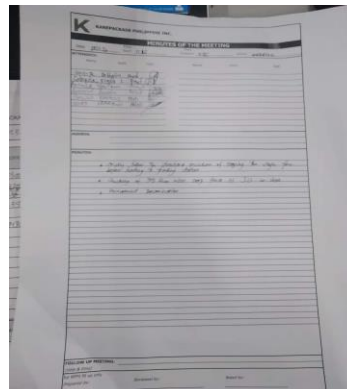
INHOUSE DETECTION: DELAMINATION  
LOT SIZE: 692  
REJECT QUANTITY: 692  
REJECTION RATE: 100%  
REMARKS: DELAMINATION

WHY 1: Delamination occurred on the lower portion of the item.

Why 2: The operator did not notice that there is a scrap on the glue roller.

Why 3: The operator failed to check the glue roller condition during running.

&gt; Checking of the glue roller every change of J.O or item.

&gt; Orient the operators regarding the issue of delamination.

&gt; Strictly follow the standard procedure of tapping the Single Face before loading to feeding station.
