INVESTIGATION REPORT

PUNCTURED

PART NAME: LOUVRE 2 NDX ICB FOR ASIA

Control No.: IRF-24-06-0030

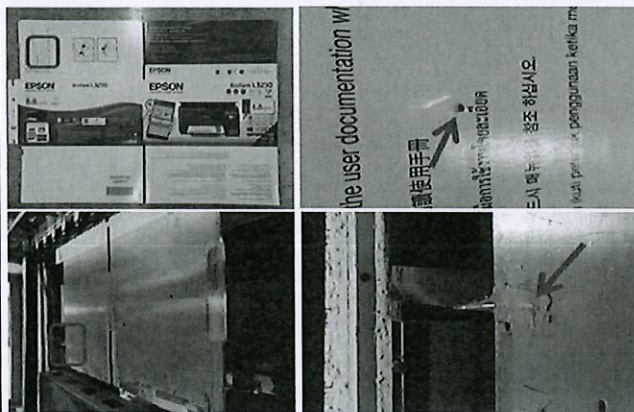
ILLUSTRATION OF THE PROBLEM

WHY 1:	WHY PUNCTURED-OFF OCCURED? BECAUSE TRIMMING TRIPPER BLADE MISALIGN FROM ITS ORIGINAL LOCATION RESULTING TO BULGE THE OTHER SIDE OF BLADE FROM THE WOODEN BOARD.
WHY 2:	WHY TRIMMING TRIPPER BLADE MISALIGN FROM ITS ORIGINAL LOCATION RESULTING TO BULGE THE OTHER SIDE OF BLADE FROM THE WOODEN BOARD. BECAUSE DURING MASS PRODUCTION SCRAP HOOK ON THE STRIPPER BLADE THAT WHEN THE OPERATOR REMOVE THE TRIMMINGS FOR MANUAL CLEANING IT DISJOINT FROM THE DIECUT BOARD CAUSING BULGING OF THE OTHER SIDE. RESULTING TO PUNCTURED IN THE SURFACE OF ITEM.
WHY 3:	WHY DURING MASS PRODUCTION SCRAP HOOK ON THE STRIPPER BLADE THAT WHEN THE OPERATOR REMOVE THE TRIMMINGS FOR MANUAL CLEANING IT DISJOINT FROM THE DIECUT BOARD CAUSING BULGING ON THE OTHER SIDE OF BLADE RESULTING TO PUNCTURED IN THE SURFACE OF ITEM. BECAUSE DIECUT SCRAP CONVEYOR IS UNDER REPAIR THAT NEED TO CONDUCT MANUAL CLEANING UNDER DIECUT MACHINE, ALSO STRIPPER BLADE IS PRONE TO BULGING DUE TO LACK OF SUPPORT THAT CAUSE IT MOVING DURING MASS PRODUCTION.

PUNCTURED

Actual:TEAR OFF WAS ENCOUNTERED ON THE ITEM
(PLEASE SEE ATTACHED PICTURE)

1	CONDUCT MEETING REGARDING ON ENCOUNTERED PROBLEM	PIC: PRODUCTION LEADER June 13, 2024
2	REMINI OPERATOT TO BE CAREFUL IN REMOVING THE SCRAP/TRIMMING WHILE THE SCRAP CONVEYOR IS STILL UNDER REPAIR.	PIC: PRODUCTION LEADER MAY 24, 2024
3	ADDITIONAL APPLICATION OF STRIPPER BLADE SUPPORT & IMPROVE THE SPACE BETWEEN CUTTING & STRIPPER (MUST BE NO SPACE) WHICH BECOME NECKMARK THAT CAUSE ALSO THE DIFFICULTY TO DETACH THE TRIMMINGS.	PIC: FOR PR OF TOOLING (JULY 01, 2024)

- remind operator to avoid pulling of scrap/trimming that
hook on the stripper blade.
- as discussed, to put support on the stripper blade to avoid
the misalignment during production.
- as part of improvement to align the space between cutting
blade & stripper blade for easy of detaching of scrap.

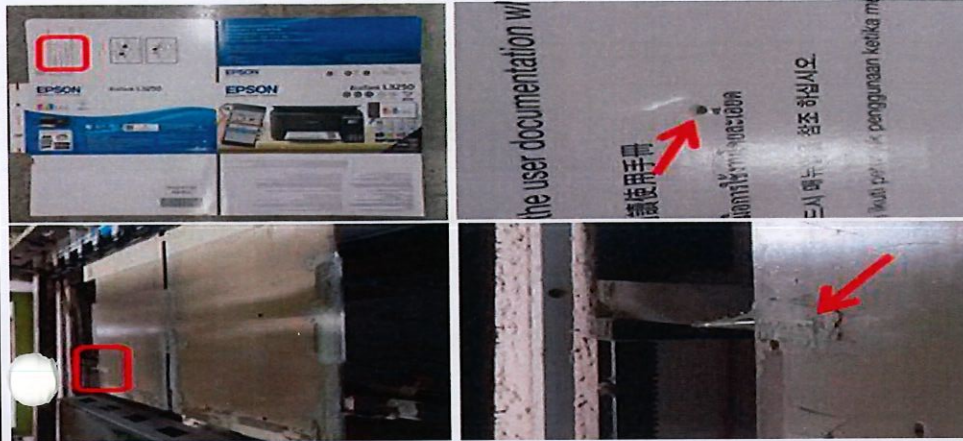
II. Visual Reference (Defect Illustration)

PUNCTURED OCCUR ON CLASS C UPPER FLAP PANEL A
DETECTED IN DIE CUT 2
PROCESS ON JUNE 10, 2024
DS DIE CUT 2
DUE TO UNEVEN SCRAP BLADE
WITH 134/1597

Related Doc. Info.	Control Number	Requirement:	ITEM SHOULD BE IN GOOD CONDITION; NO OCCURRENCE OF PUNCTURED
<input type="checkbox"/> Procedure Manual :		Actual:	PUNCTURED OCCUR ON UPPER CLASS C / PANEL A
<input type="checkbox"/> Technical Drawing :		Conclusion and Recommendation:	CHECKING OF STRIPPER BEFORE RUNNING CHECKING OF SAMPLING DURING RUNNING DUE TO UNEVEN SCRAP BLADE
<input type="checkbox"/> Work Instruction :			<input type="checkbox"/> Applicable <input type="checkbox"/> Not Applicable
<input type="checkbox"/> Job Order :			
<input type="checkbox"/> Reports :			
<input type="checkbox"/> Defect Limit :
