## Investigation Report for Misalign Diecut of Superflex PKC404B-B Motor Inner Box

CONTROL No:	IRF - 0004			REJECT PERCENTAGE:	0.91%
REJECT QTY:	82	LOT QTY:	9000

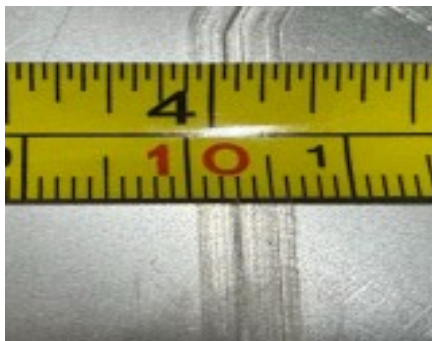
DIRECT CAUSE	W1	The factor we consider cannot fit lock is due to abnormal lateral movement of Eterna die-chase.
	W2	The die-chase moved up to 7mm in the lateral direction (Left & Right) during mass production even though it was locked.
	W3	Due to the die-chase movement the creasing blade didn't hit the center of creasing matrix that may caused bursting.

Evidence of diecut movement in steel plate

CORRECTIVE ACTION	Replacement of 6pcs die-chase spring.	PIC:	Engineering & Caledonian	TARGET DATE:	240630
CORRECTIVE ACTION	Include the die-chase spring in Engineering Machine History Sheet of Eterna. This is the basis of Engineering for the monitoring of machine parts life span for those parts that only Caledonian can maintenance or check.	PIC:	Engineering	TARGET DATE:	240630

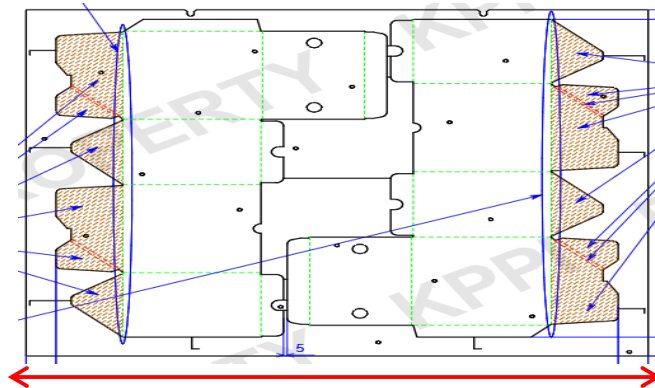
The movement of the die-chase corresponds to the caused of reject items
