# Investigation Report for Bursting of Merasenko 473MB-RMFG Oxygen Tube

CONTROL No:	IRF - 0006			REJECT PERCENTAGE:	2.90%
REJECT QTY:	29	LOT QTY:	1000

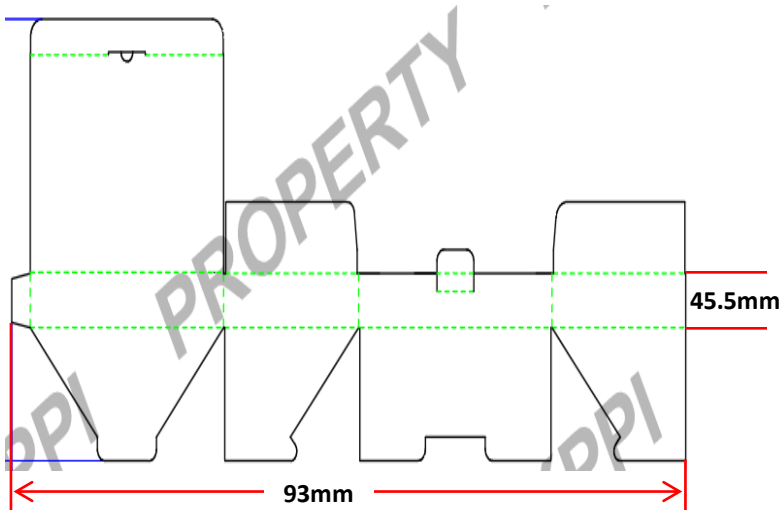
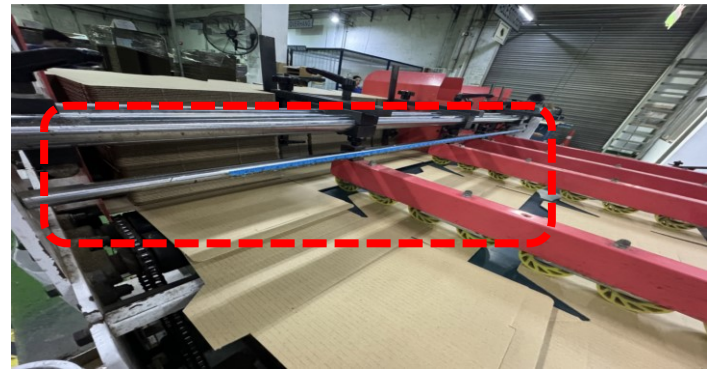
DIRECT CAUSE	W1	Items process in S1700 and without application of creasing matrix, in this condition it is impossible to have bursting at the outer portion or white kraft.
	W2	The factor we consider is tear off due to slanting of item in SD1800 feeder.
	W3	Based on interview in SD1800 operator they encounter tear off including in this item if there is slanting of item in SD1800 feeder.
	W3	Since this item have only 45.5mm height dimension and 913mm length it become prone to tear off when got slanted in SD1800 feeder.

SLANTING OF ITEM HAPPENED IN THIS PORTION OF SD1800 THAT CAUSED TEAR OFF

IMMEDIATE ACTION	Conduct study in SD1800 on how to improve the occurrence of slanting of items in feeder area of SD1800 then give update to QA for the Corrective Action	PIC:	Production Leaders	TARGET DATE:	240719
------------------	---	------	--------------------	--------------	--------
