Investigation Report for Extra Fold of CBMP RX1-5732-000 Z10 Sleeve

CONTROL No:	IRF - 0007			REJECT PERCENTAGE:	4.33%
REJECT QTY:	26	LOT QTY:	600

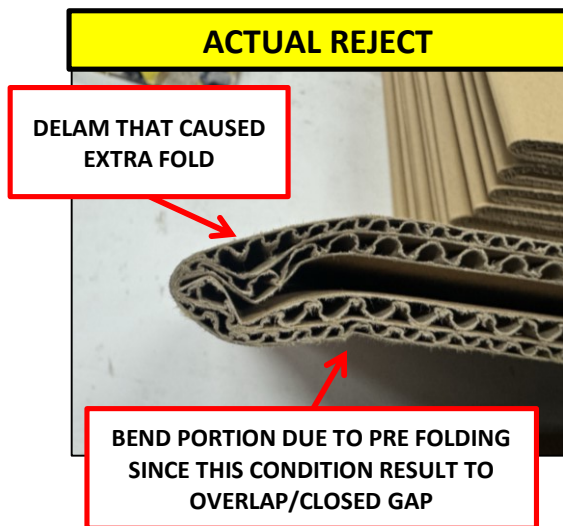
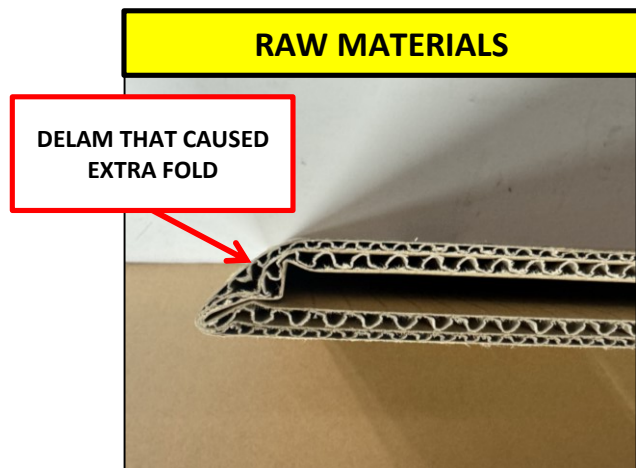
DIRECT CAUSE	W1	Based on investigation conducted to actual process the caused of Extra fold is the delamination of board during pre folding.
	W2	During pre folding of sleeve we heard random of crunchy sound then upon checking its automatically have extra fold due to delamination.

INDIRECT CAUSE (OUTFLOW)	W1	That condition result to overlap/closed gap and since operator didn't expect that this item was affected of extra fold, they conducted pre folding (HILOT) that resulting pain in their hands due to the hardness of the material
--------------------------	----	---

CORRECTIVE ACTION	Conducted orientation to Manual Gluing operator regarding this investigation and instruct them that all affected of delamination was separate and reject consider as supplier reject.	PIC:	Production Leader	TARGET DATE:	240717
CORRECTIVE ACTION	Coordinate to QA regarding improvement on supplier side since this item is actual sheets with creasing from supplier.	PIC:	QA	TARGET DATE:	240717
