Investigation Report for Misalign Diecut of Arkray 84-05467A Inner Box F821629-1

CONTROL No:	IRF - 0009			REJECT PERCENTAGE:	1.32%
REJECT QTY:	27	LOT QTY:	2050

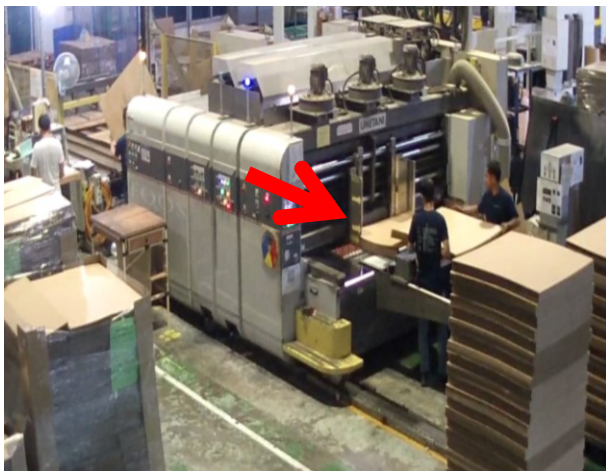
DIRECT CAUSE	W1	We also consider misalign print in investigation but no factor found in Eqos since upon checking of CCTV Eqos operator follow on the Standard Height Limit Set in Eqos Feeder.
	W2	The factor that consider contributing random of misalign print is the abnormal lateral movement of Eterna die-chase of almost 7mm due to worn-out die-chase spring.
	W3	The die-chase movement corresponds on the misalignment based on the blade layout and print. Since only 8mm the gap of print to creasing line the movement of die-chase resulted to random misalign diecut.

Eqos operator follow on the Standard Height Limit Set in Eqos Feeder.

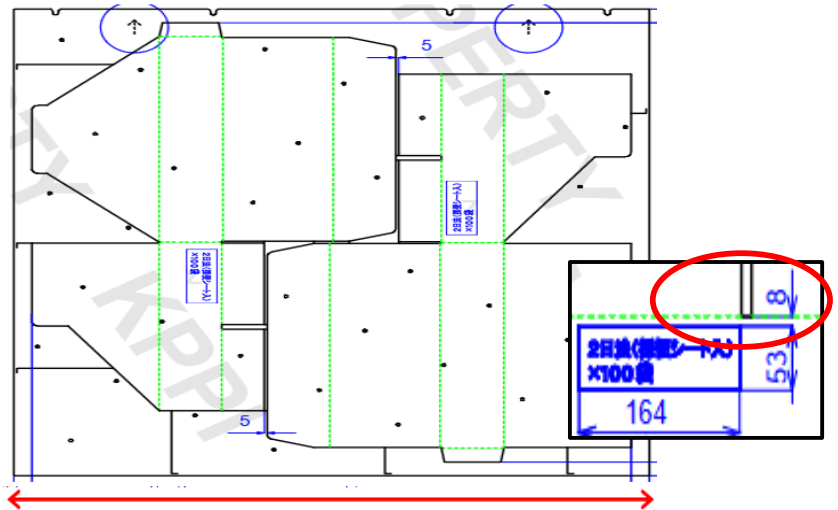
The movement of the die-chase corresponds to the reject items

CORRECTIVE ACTION	Replacement of 6pcs worn-out die-chase spring.	PIC:	Engineering & Caledonian	TARGET DATE:	240731
CORRECTIVE ACTION	Include the die-chase spring in Engineering Machine History Sheet of Eterna. This is the basis of Engineering for the monitoring of machine parts life span for those parts that only Caledonian can maintenance or check.	PIC:	Engineering	TARGET DATE:	240731
