# Investigation Report for Misalign Glue of Arkray 8405467A Inner Box

CONTROL No:	IRF - 0008			REJECT PERCENTAGE:	1.95%
REJECT QTY:	40	LOT QTY:	2050

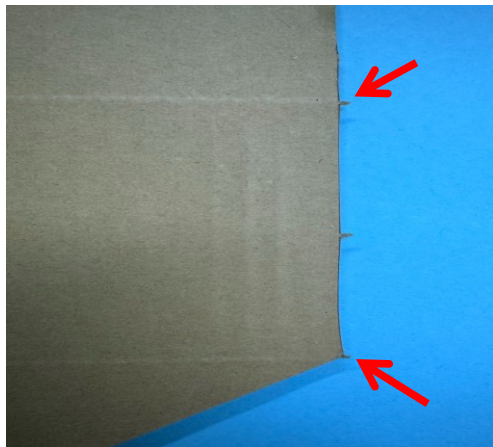
DIRECT CAUSE	W1	Item already have existing improvement of putting nick mark in vertical and horizontal portion of glue tab as alignment reference during Gluing process.
	W2	The horizontal nick mark is effective since its visible, but the vertical nick mark is not so visible possible because its along grain direction.
	W3	Based on investigation and interview to manual gluing operator there is difficulty to align the vertical gluing alignment of this item since the design is off set lower flap and the applied vertical nick mark in the glue tab is not visible.

VISIBLE NICK MARK ON HORIZONTAL  
POSITION CROSS GRAIN DIRECTION

CORRECTIVE ACTION	Since the diecut process of this item is in Eterna, the corrective action is the application of creasing matrix on the glue tab portion for more visible marking reference in gluing alignment.	PIC:	Production leader & Operator	TARGET DATE:	240809
IMMEDIATE ACTION	Attachment of note in the die-blade that inform the leader next running for the improvement of creasing matrix application on the glue tab.	PIC:	Gerald De Guzman	TARGET DATE:	240723

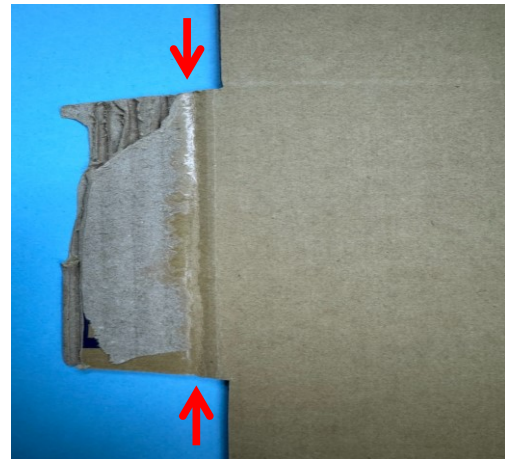
VISIBLE NICK MARK ON HORIZONTAL  
POSITION CROSS GRAIN DIRECTION
