## Investigation Report for Overlap of CBMP RX1-5755-000 Z10 CARTON

<b>CONTROL No:</b>	<b>IRF - 0012</b>			<b>REJECT PERCENTAGE:</b>	<b>3.14%</b>
<b>REJECT QTY:</b>	<b>33</b>	<b>LOT QTY:</b>	<b>1050</b>

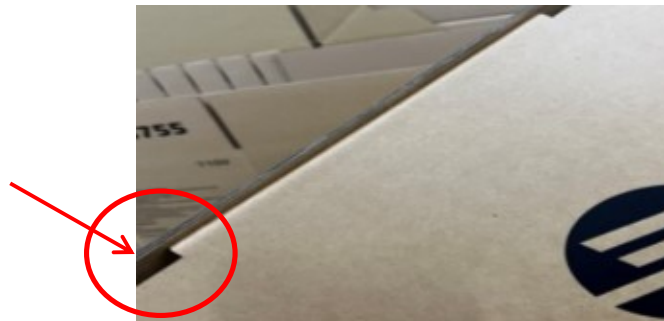
<b>DIRECT CAUSE</b>	<b>W1</b>	Based on investigation the defect is not overlap due to due to closed gap since in actual the gap in glue tab is sufficient.
	<b>W2</b>	The factor we consider in this defect is that misalign creasing of glue tab.
	<b>W3</b>	When the creasing blade hit the grain direction line which is hard portion, the glue tab got misalign during pre folding in Gluing process.
	<b>W3</b>	Due to misalign creasing of glue tab, the attachment at end portion of glue tab was detach and looks like overlap.

**SUFFICIENT GAP  
FROM GLUE TAB**

<b>CORRECTIVE ACTION</b>	Problem is un controllable since the Diecut process of this item is in Diecut S1700, but it was reworkable by re-folding the glue tab and applying small amount of glue.	<b>PIC:</b>	<b>QA &amp; Production</b>	<b>TARGET DATE:</b>	<b>Next running if have same defect.</b>
<b>CORRECTIVE ACTION</b>	Inclusion in (WI-PR-004-018) Work and Safety Instruction for Manual Gluing of Canon Carton Box the rework process of this defect by re-folding the glue tab and applying small amount of glue.	<b>PIC:</b>	<b>Production IE</b>	<b>TARGET DATE:</b>	<b>240830</b>
