# Investigation Report for Scoring of CBMP 3CB-0004-00 Partition

<b>CONTROL No:</b>	IRF - 0014			<b>REJECT PERCENTAGE:</b>	6.88%
<b>REJECT QTY:</b>	69	<b>LOT QTY:</b>	1003

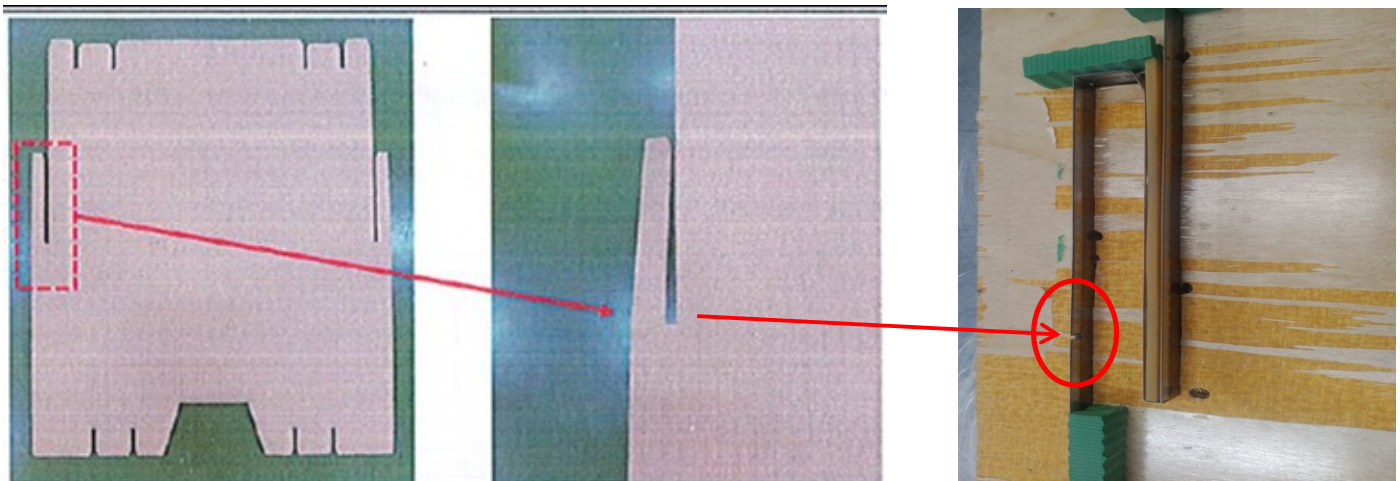
<b>DIRECT CAUSE</b>	<b>W1</b>	The affected slot portion is forced to scoring during detaching process.
	<b>W2</b>	Due to incorrect application of nick mark
	<b>W3</b>	There is nick mark on the slot portion that clings to the trimming during detach process which resulted in scoring.

<b>IMMEDIATE ACTION</b>	Orient the Detaching operator regarding to criticality of this item in scoring.	<b>PIC:</b>	Production leaders	<b>TARGET DATE:</b>	241024
<b>IMMEDIATE ACTION</b>	Repair of die-blade by replacing the affected cutting blade.	<b>PIC:</b>	Production leaders	<b>TARGET DATE:</b>	241023
<b>CORRECTIVE ACTION</b>	Visual Guidelines for Tooling Custodian regarding proper way of putting Nick Mark.	<b>PIC:</b>	Gerald De Guzman	<b>TARGET DATE:</b>	241031
