Investigation Report on Misalign cut of Lionel MGY Asia 516555500

CONTROL No:	IRF - 0088			REJECT PERCENTAGE:	4.19%
REJECT QTY:	39	LOT QTY:	930

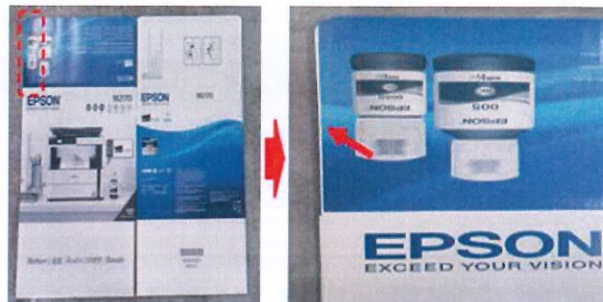
REJECT :

DIRECT CAUSE	W1	Misalign cut was due to deformed PS of item.
	W2	Deformed PS was due to applied cover of stretch film Thin PS prone to deformed during stocking process in the loader area that hit the feeder sensor.
	W3	Thin printed sheets hit the cover of upper feeder sensor during mass production.
	W4	When printed sheet hit the feeder sensor it cause failed to detect the passing of printed sheet that cause misalign between printed and single face.
	W5	n/a

IMMEDIATE ACTION	Notify the concern operator about the problem encountered.	PIC:	Prod Leader	TARGET DATE:	July 10, 2025
IMMEDIATE ACTION	Segregation of laminated boards with misalign single face and to have a different set-up in diecut to process the item with misalign problem.	PIC:	Operator	TARGET DATE:	July 10, 2025
CORRECTIVE ACTION	Operator to pressed the 4 corners of printed Sheet to avoid touching the feeder sensor cover.	PIC:	Operator	TARGET DATE:	July 28, 2025
CORRECTIVE ACTION	Operator to pressed the 4 corners of printed Sheet to avoid touching the feeder sensor cover.	PIC:	Operator	TARGET DATE:	July 28, 2025
CORRECTIVE ACTION	Provide reminders in Lamination area regarding the pressing processing process of 4 corners of PS applicable for Linus PS only	PIC:	Operator	TARGET DATE:	July 28, 2025
CORRECTIVE ACTION	Orientation to operator in conduction pressing in the 4 corners of printed sheet.	PIC:	Operator	TARGET DATE:	July 28, 2025
