Investigation Report: Damage

CONTROL No:	AR-09-0010		REJECT PERCENTAGE:	3.20%
REJECT QTY:	32	LOT QTY:	1000

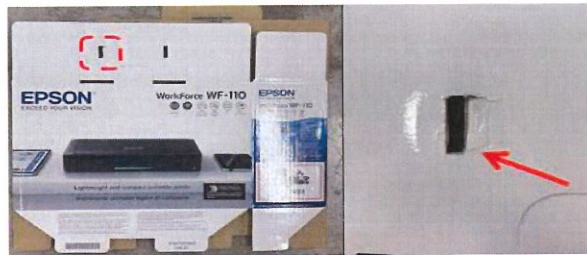
NO GOOD :

DIRECT CAUSE	W1	The slot portion of the ICB is damaged during the detaching of the scrap.
	W2	The detaching tool used hits and damages the slot portion.
	W3	The detaching tool being used is not appropriate for the slot of the ICB.
	W4	Improvised tool (specifically, a cyrel stick) is being used instead of the correct, purpose-designed tool.

IMMEDIATE ACTION	Re-orientation of operators to limit the numbers of detaching quantity until correct tools has been provided	PIC:	Production operators	TARGET DATE:	October 6, 2025
CORRECTIVE ACTION	Request and fabricate tools for detaching process	PIC:	Production operators	TARGET DATE:	October 7, 2025
