Investigation Report: Damage on 5163364-00 Muffin Box

CONTROL No:	AR-10-0005			REJECT PERCENTAGE:	4.00%
REJECT QTY:	24	LOT QTY:	600

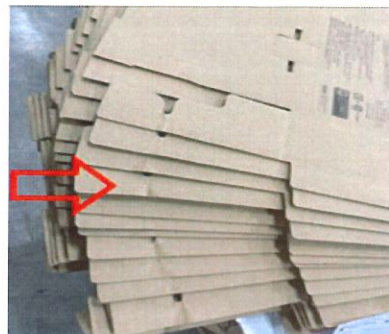
NO GOOD :

DIRECT CAUSE	W1	Damage occur during manual stripping process
	W2	During pulling of scrap material the affected portion also pulled out causing damage
	W3	The affected portion has no cutting blade
	W4	The stripping process of the scrapp is not considered during the design of the die cut blade

IMMEDIATE ACTION	Orient the operators regarding proper manual detaching	PIC:	Production leaders	TARGET DATE:	October 6, 2025
CORRECTIVE ACTION	Attached sutera blade to have cutting on the affected portion and sperate it during pulling of outer scrap	PIC:	Production Toolings	TARGET DATE:	October 6, 2025
