Investigation Report of Peel off Defects on OCB 5136711-00

CONTROL No:	IRF-26-01-97		REJECT PERCENTAGE:	4.48%
REJECT QTY:	112	LOT QTY:

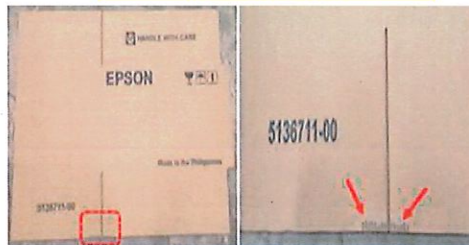
DIRECT CAUSE	W1	Peel off Encountered in EQOS Process mass Production
	W2	Edge of the ICB hit the front guide of the feeder section
	W3	The boards is warp and the position of the warpage is varying
	W4	
	W5

IMMEDIATE ACTION	Conduct orientation to EQOS operator for the defect encountered and advised if the warpage is more than the allowed limit, don't process the material and conduct repalletizing and reconditioning.	PIC:	Prod Leader	TARGET DATE:	260121
CORRECTIVE ACTION	Apply the principle of moving the feeder guide where the is no warpage same as the concept for VOION E FLUTE MATERIAL	PIC:	Prod Leader	TARGET DATE:	260121
