Investigation Report of Lamination Glue Stain on LOUVRE 2 ICB 5165913-00

CONTROL No:	IRF-25-01-0098		REJECT PERCENTAGE:	4.00%
REJECT QTY:	64	LOT QTY:

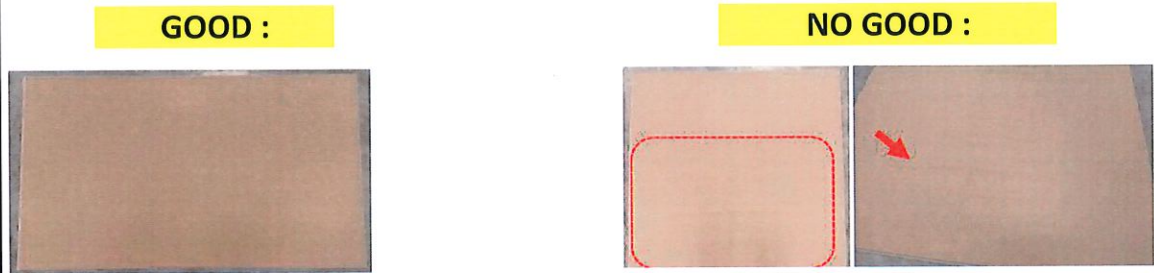
ILLUSTRATION:

DIRECT CAUSE	W1	Glue stain occur on lamination mass production
	W2	Glue contamination occur on water catch pan
	W3	Main supply of water has been turn off
	W4	There is a leak on the main valve of the water supply
	W5	The gate valve of the water supply is damage.

IMMEDIATE ACTION	Wash up the roller using the running water. Also conduct cleaning of the glue palate of the lamination machine	PIC:	Prod Leader	TARGET DATE:	260113
CORRECTIVE ACTION	Repair and change the gate valve of the water supply in lamination.	PIC:	Engineering	TARGET DATE:	260120
