## Investigation Report on Dented of Linus ICB for Asia 516182300

<b>CONTROL No:</b>	<b>IRF - 0083</b>			<b>REJECT PERCENTAGE:</b>	4.20%
<b>REJECT QTY:</b>	42	<b>LOT QTY:</b>	1000

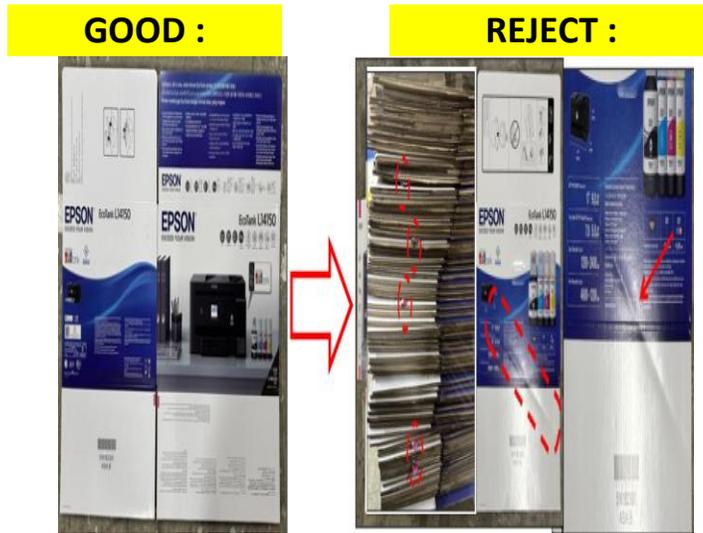
**ILLUSTRATION:**

<b>DIRECT CAUSE</b>	<b>W1</b>	Dented on Linus ICB was due to scrap or uncut trimmings left between the diecutted panels.
	<b>W2</b>	Uncut trimmings was due to damage of auto stripper lock, which was unable to remove the trimming after
	<b>W3</b>	Damage of auto stripper lock was due loose board that hit the stripper during mass production.
	<b>W4</b>	n/a
	<b>W4</b>	n/a

<b>IMMEDIATE ACTION</b>	Catcher operator to clean the trimming at the top of item prior placing of another batch of diecutted panels.	<b>PIC:</b>	Prod Leader	<b>TARGET DATE:</b>	May 18, 2025
<b>IMMEDIATE ACTION</b>	Additional nick mark in the blade to control the loose board problem.	<b>PIC:</b>	Tooling	<b>TARGET DATE:</b>	May 18, 2025
<b>IMMEDIATE ACTION</b>	Request of Eworks to Engineering team.	<b>PIC:</b>	Tooling	<b>TARGET DATE:</b>	June 16, 2025
<b>CORRECTIVE ACTION</b>	Replacement of Auto stripper lock of Deicut machine.	<b>PIC:</b>	Engineering Team	<b>TARGET DATE:</b>	July 02, 2025
