INVESTIGATION REPORT FORM (IRF)
☒ Inhouse Detection

Customer	EPSON IJP	Attention To	Mr. Gerald De Guzman
Item Code	5150864-01	Department	PRODUCTION
Item Description	INDIVIDUAL BOX	Date of Detection	20 08 08
Job Order Number	WO-20-L-0068-28	Section Detected	QA - IN LINE

INVESTIGATION REPORT FOR GLUE STAIN OF EPSON IJP 5150864-01 INDIVIDUAL BOX

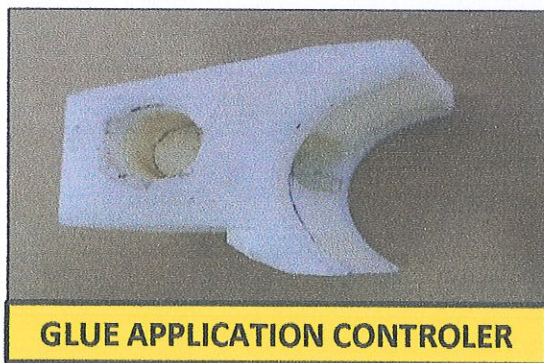
GLUE APPLICATION CONTROLLER

DIRECT CAUSE PROCESS/MATERIAL	W2- The glue stain occurs due to leak of excess glue in the glue tab during piling.
	W1- The application of glue in the glue tab is so thick.
	W3- The supplied of glue from Glue Applicator Roller is thick.
	W4- The Glue Application Controller is already worn-out and subject for replacement why the flow of glue in glue applicator roller is thick and hard to control.

INDIRECT CAUSE PROCESS/MATERIAL	W1- Even operator wipe the excess glue the stain will remain
---	---

Request for the replacement of Glue Application Controller.			
PIC:	PRODUCTION	TARGET DATE:	DONE 200803

Operator do temporary remedy in Glue Application Controller to control the flow of glue.			
PIC:	PRODUCTION	TARGET DATE:	ON-GOING

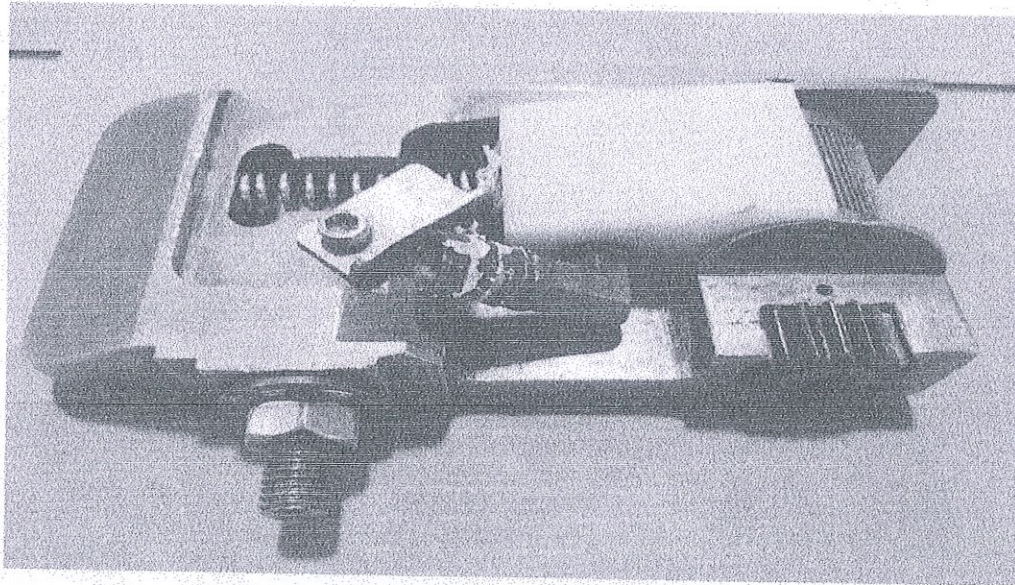
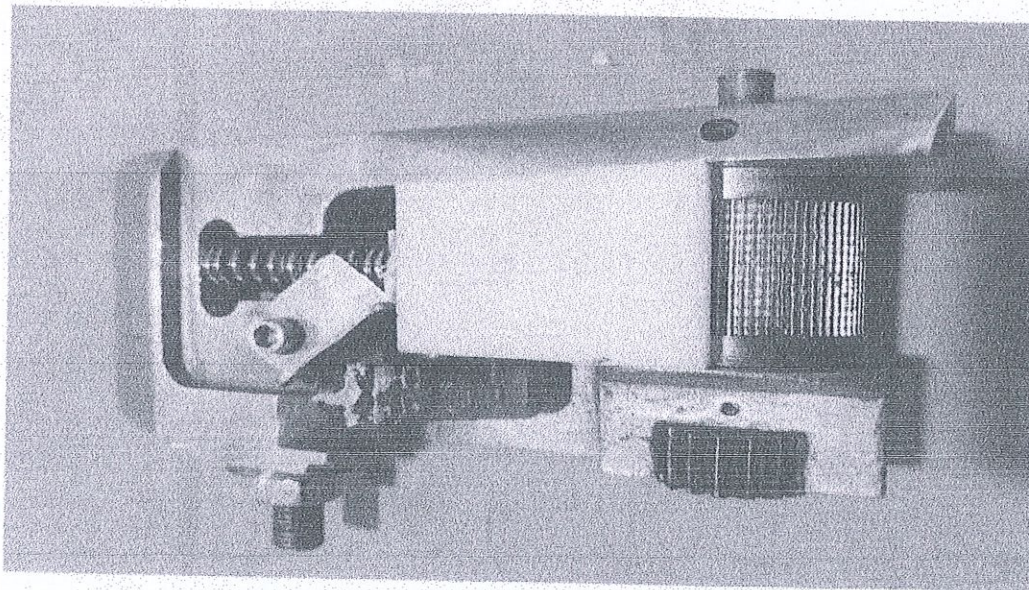
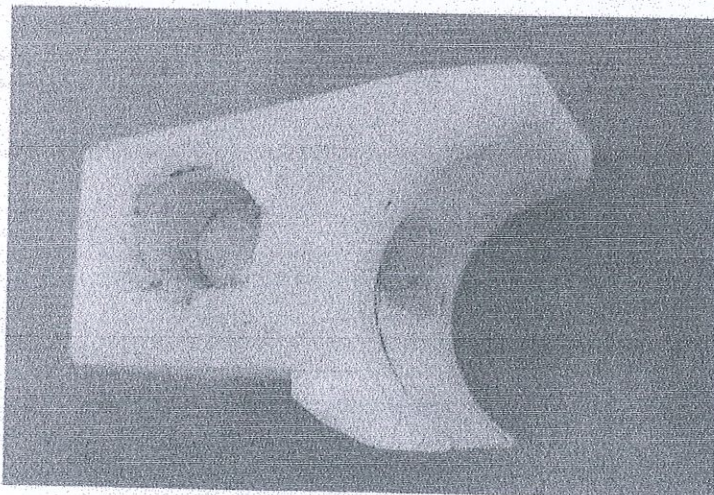
SEMI-AUTO GLUING (GLUE APPLICATOR)

SEMI-AUTO GLUING GLUE APPLICATOR
