**KANEPACKAGE PHILIPPINE INC.**

**INVESTIGATION REPORT FORM (IRF)**
☐ Inhouse Detection

# INVESTIGATION REPORT FOR MISALIGN PRINT OF SANYO DENKI 00415456-01 PACKAGE

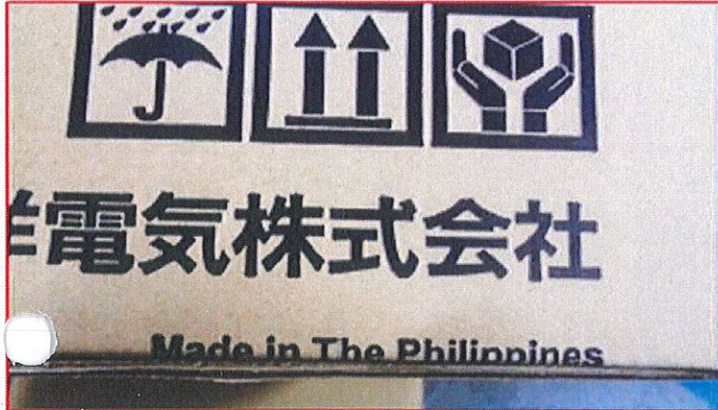
**ILLUSTRATION OF THE PROBLEM**

MISALIGN PRINT

Print should not exceed on the creasing line

The print exceeded on the creasing line
