<b>KANEPACKAGE PHILIPPINE INC.</b> No. 5 Ring Road LISP II, Brgy. La Mesa, Calamba City, Laguna Telephone No. (049) 545-7166 to 69 Fax No. (049) 545-6302	<b>INVESTIGATION REPORT</b>		
	Prepared By:	Check By:	Approved By:
<b>DATE:</b>	MAY 25, 2023	K. DIAZ QA-IE/ Prodn IE	N. CEPEDA QA/ Prodn SV
		R. MIRANDA KPLIMA Operations Gen. Mngr.

<b>1.1. ISSUE:</b>	
	NO CREASING MATRIX
<b>1.2. ITEM DESCRIPTION:</b>	
<b>PART CODE:</b>	513648400
<b>PART NAME:</b>	STRATOS WITH STICKER
<b>1.3. BACKGROUND:</b>	
<b>PICTURE</b>

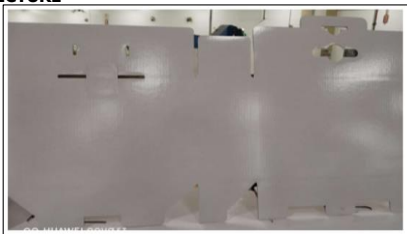
<b>DETAILS:</b> >Inhouse Detection : NO CREASING MATRIX >Lot size: 277pcs > Reject Qty: 277pcs >Rejection Rate: 100% >JO#: 36563

<b>WHY 1:</b>	No creasing matrix occur at Die-cut machine 3 for the item 513648400 -Stratos with Sticker
<b>WHY 2:</b>	No creasing matrix because the operator did not change the plate
<b>WHY 3:</b>	The operator is unsure whether the item needs a creasing matrix or not from the description. Note: the operator did not notice that the description need a creasing matrix. The operator procced tin mass production without changing plate where no creasing matrix occurred.

1	Replacement of pattern sheet for Light MA and FA.	PIC: Tooling Custodian and Subleader Target Date: May 19, 2023
2	Orientation to diecut operator regarding the encountered damaged due to uncut and proper use of backing tape and proper disposal of pattern sheet that was worn out.	PIC: Production IE Target Date: May 19, 2023
3	To have a monitoring to have a pattern sheet lifespan. Note: This is still under observation if needed and could be feasible.	PIC: Production IE Target Date: June, 2023
4	Generate an OPL (One Point Lesson) as an eyemark for the diecut operators regarding proper use of backing tape and pattern sheet as well.	PIC: Production IE Target Date: May 24, 2023 or next mass production
