KANEPACKAGE PHILIPPINE INC. No. 5 Ring Road LISP II, Brgy. La Mesa, Calamba City, Laguna Telephone No. (049) 545-7166 to 69 Fax No. (049) 545-6302	<h1>INVESTIGATION REPORT</h1>		
	Prepared By:	Check By:	Approved By:
	K. DIAZ	N. CEPEDA	R. MIRANDA
DATE:	August 3, 2023	QA-IE/ Prodn IE	QA/ Prodn SV
		KPLIMA Operations Gen. Mngr.

1.1. ISSUE:	
	BURSTING
1.2. ITEM DESCRIPTION:	
PART CODE:	515913300
PART NAME:	LOUVRE MJX CHINA
1.3. BACKGROUND:	
PICTURE

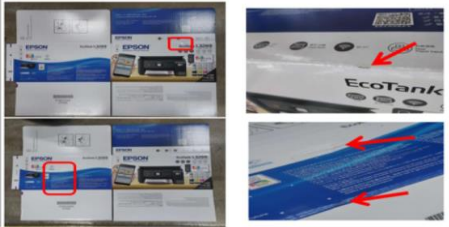
DETAILS: >Inhouse Detection :BURSTING >Lot size: 694pcs > Reject Qty: 80pcs >Rejection Rate: 11.52%

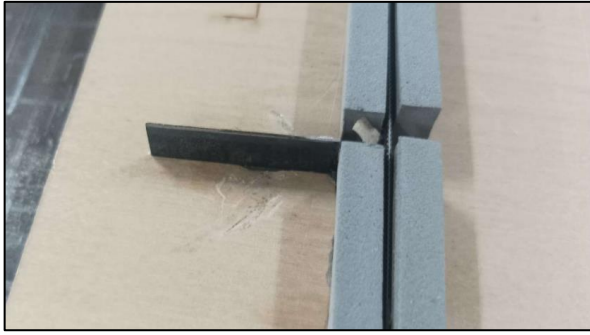
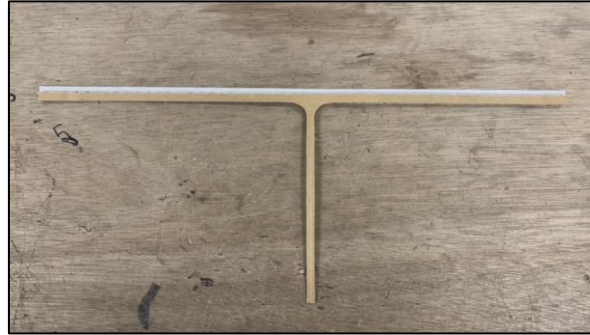
WHY 1:	Bursting occurred on the flap (folding portion) of the item 515913300 Louvre 2 MJX China.
WHY 2:	Bursting was due to encountered scrap left on the diecut plate.
WHY 3:	Scrap left on the diecut plate was due to having no nickmark on the scrap blade.
WHY 4:	No nickmark on the scrap blade was unnoticed by both tooling and operator prior usage.
WHY 5:	There is no standard work instruction and checking form for putting of nickmark for the scrap blade.

ACTUAL SCRAP ON THE PLATE (T) AND NO NICKMARKS ON SCRAP BLADE PORTION RESULTING

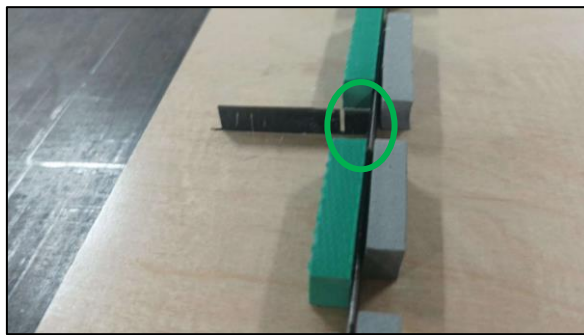
ADDED NICKMARK ON THE SCRAP BLADE PORTION BY TOOLING CUSTODIAN

1	The tooling custodian put nickmark on the scrap blade.	PIC: Tooling Custodian Target Date: July 31, 2023
2	Revision of work instruction for blade checking. Note: Add standard for putting of nickmark on scrap blade. ~Blade for manual strip: No nickmark ~Blade for auto strip: With nickmark	PIC: Production IE Target Date: August 5, 2023
3	Revision of tooling custodian checksheet for production tooling daily issuance. Note: Additional checkpoints of nickmark on scrap blade prior issuance to Production.	PIC: Production IE Target Date: August 5, 2023
